## General Information

| Make | Toyota | Model | Wigo |

## Body / Panel Condition

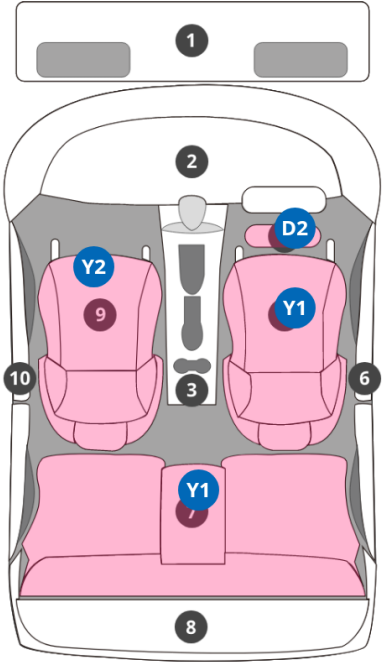
| Interior Evaluation : <b>A</b> | Exterior Evaluation : <b>B</b> |
|---|---|
| <b>Remarks</b><br>(R) Front Seat - Grime - Minimal / Rear Seat - Grime - Minimal / (L) Front Seat - Grime - Small / (L) Front Floor Mat - Worked - Small | <b>Remarks</b><br>(R) Front Fender, Molding - Scratch & Dent - Small / (R) Front Door, Molding - Scratch - Minimal / (R) Rear Fender, Molding - Scratch - Minimal / (R) Rear Door, Molding - Scratch - Minimal / Rear Bumper, Lamps, Panels - Scratch - Medium / Trunk Hood, Rear Gate - Scratch - Minimal / (L) Rear Fender, Molding - Scratch - Small / (L) Rear Door, Molding - Scratch - Minimal / (L) Front Door, Molding - Scratch - Minimal / (L) Mirror - Scratch - Small / (L) Front Fender, Molding - Scratch - Minimal / Front Bumper, Grille, Lamps - Scratch - Small / Bonnet, Headlight - Scratch - Minimal / Roof - Scratch - Minimal |
