## General Information

| Make | Toyota | Model | Vios |
| YOM | 2024 | Odo Meter Reading | 59,104 |
| Registration No. | BAG3206 | Chassis No. | PA1B18F34R4257582 |

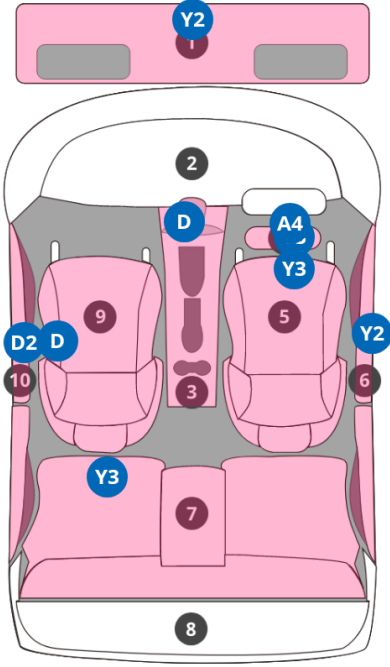
| Interior Evaluation : <b>C</b> | Exterior Evaluation : <b>D</b> |
| <p><b>Remarks</b></p> <p>(L) Front Seat - Worn - Yes / (R) Front Seat - Grime - Medium / Rear Seat - Grime - Medium / Mat Other - Grime - Medium / (R) Front Trim - Grime - Small / Console, Switches, Vents - Traces of Adhesive Tape - Yes / (L) Front Floor Mat - Cut, Crack - Large / (L) Front Trim - Worked - Small / Ceiling - Grime - Small</p> | <p><b>Remarks</b></p> <p>Bonnet, Headlight - Repair mark - Difference in Color / (R) Front Fender, Molding - Dent - Small / (R) Front Door, Molding - Dent - Small / (R) Step, In-panel, Side Spoiler - Dent - Small / (R) Rear Door, Molding - Scratch - Small / (R) Rear Fender, Molding - Scratch - Minimal / Rear Bumper, Lamps, Panels - Scratch - Medium / Trunk Hood, Rear Gate - Scratch - Minimal / (L) Rear Door, Molding - Scratch - Minimal / (L) Front Fender, Molding - Scratch - Small / Member (Bolted) - Dent - Yes / Front Bumper, Grille, Lamps - Crack, Gap - Medium / Bonnet, Headlight - Scratch &amp; Dent - Medium / (L) Front Door, Molding - Scratch &amp; Dent - Medium / Roof - Scratch - Small / (L) Rear Fender, Molding - Dent - Small</p> |

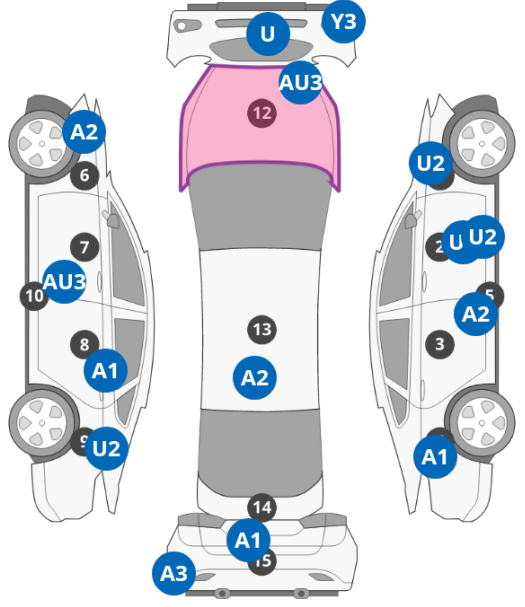
| Inspector Notes |
|---|
| no warranty booklet, with jack, no tools, with spare tire, with LTO plate, scratched and cracked tail light, headlight unit issue |
