## General Information

| Make | Toyota | Model | Vios |
| Registration No. | BAG3721 | Chassis No. | PA1B18F3XR4258509 |

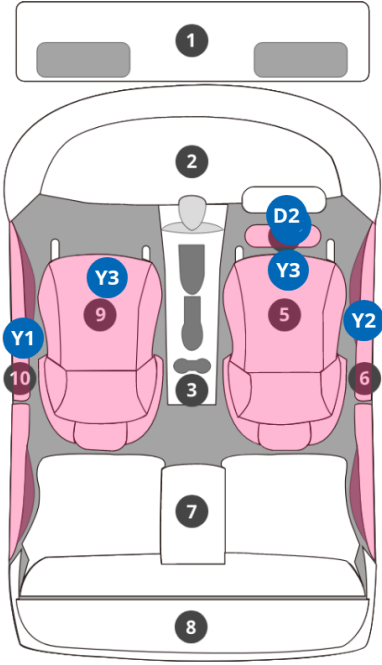
| Interior Evaluation : <b>B</b> | Exterior Evaluation : <b>D</b> |
| <b>Remarks</b><br>(R) Front Seat - Grime - Medium / (L) Front Seat - Grime - Medium / (R) Front Floor Mat - Grime - Medium / (L) Front Floor Mat - Worked - Small / (R) Front Trim - Grime - Small / (L) Front Trim - Grime - Minimal | <b>Remarks</b><br>(R) Front Fender, Molding - Scratch & Dent - Medium / (R) Mirror - Scratch - Small / (R) Front Door, Molding - Scratch & Dent - Medium / (R) Rear Door, Molding - Scratch - Small / Rear Bumper, Lamps, Panels - Scratch - Large / (R) Rear Fender, Molding - Scratch & Dent - Small / Trunk Hood, Rear Gate - Crack, Gap - Medium / (L) Rear Fender, Molding - Scratch - Minimal / (L) Front Door, Molding - Scratch & Dent - Small / (L) Rear Door, Molding - Scratch - Small / (L) Mirror - Scratch - Small / (L) Front Fender, Molding - Scratch - Minimal / Member (Bolted) - Dent - Yes / Front Bumper, Grille, Lamps - Scratch & Dent - Medium / Bonnet, Headlight - Scratch - Minimal / Roof - Scratch - Minimal |
