## General Information

| Make | Toyota | Model | Wigo |

## Body / Panel Condition

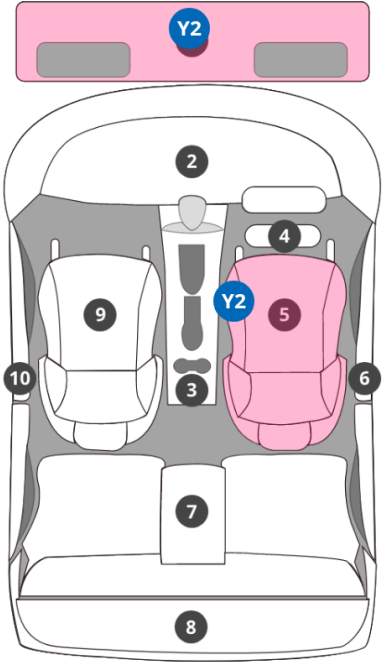
| Interior Evaluation : <b>A</b> | Exterior Evaluation : <b>C</b> |
| <p><b>Remarks</b><br/>Ceiling - Grime - Small / (R) Front Seat - Grime - Small</p> | <p><b>Remarks</b><br/>Trunk Hood, Rear Gate - Repair Traces - Yes / (R) Front Door, Molding - Scratch - Small / (R) Rear Door, Molding - Scratch - Small / (R) Rear Fender, Molding - Scratch - Small / (L) Rear Door, Molding - Scratch - Small / (L) Front Door, Molding - Scratch - Small / (L) Front Fender, Molding - Scratch - Small / Bonnet, Headlight - Scratch &amp; Dent - Small / (R) Front Fender, Molding - Scratch - Medium / Front Bumper, Grille, Lamps - Scratch &amp; Dent - Large / Trunk Hood, Rear Gate - Scratch - Minimal / Rear Bumper, Lamps, Panels - Scratch - Small / (L) Rear Fender, Molding - Scratch - Minimal</p> |
