## General Information

| Make | Toyota | Model | Vios |

## Overall Evaluation :

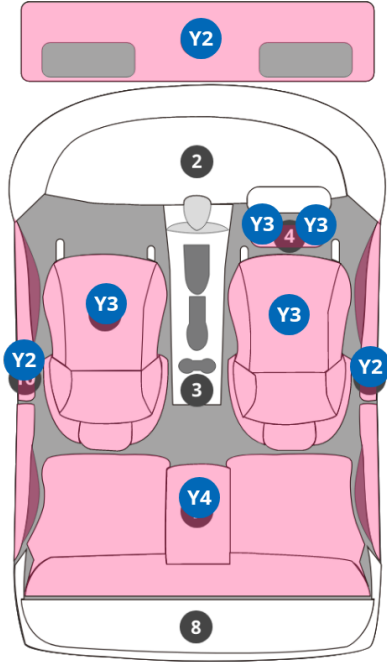
| Interior Evaluation : <b>C</b> | Exterior Evaluation : <b>E</b> |
|---|---|
| <p><b>Remarks</b></p> <p>Ceiling - Grime - Small / (R) Front Trim - Grime - Small / (R) Front Floor Mat - Grime - Medium / (R) Front Seat - Grime - Medium / Rear Seat - Grime - Large / (L) Front Trim - Grime - Small / (L) Front Floor Mat - Grime - Medium / (L) Front Seat - Grime - Medium</p> | <p><b>Remarks</b></p> <p>(L) Front Fender - Repair Traces - Yes / (L) Rear Door, Molding - Scratch &amp; Dent - Large / (L) Front Door, Molding - Scratch - Small / (L) Mirror - Scratch - Small / (L) Front Fender, Molding - Scratch - Small / Bonnet, Headlight - Scratch - Medium / Front Bumper, Grille, Lamps - Scratch &amp; Dent - Medium / (R) Front Fender, Molding - Scratch - Small / (R) Mirror - Scratch - Small / (R) Front Door, Molding - Scratch - Small / (R) Step, In-panel, Side Spoiler - Scratch &amp; Dent - Medium / (R) Rear Fender, Molding - Scratch - Small / Trunk Hood, Rear Gate - Scratch - Small / Rear Bumper, Lamps, Panels - Scratch &amp; Dent - Large / (L) Rear Fender, Molding - Scratch - Small / Front Windshield - Scratch, Stone chip - Large / Roof - Scratch - Large</p> |

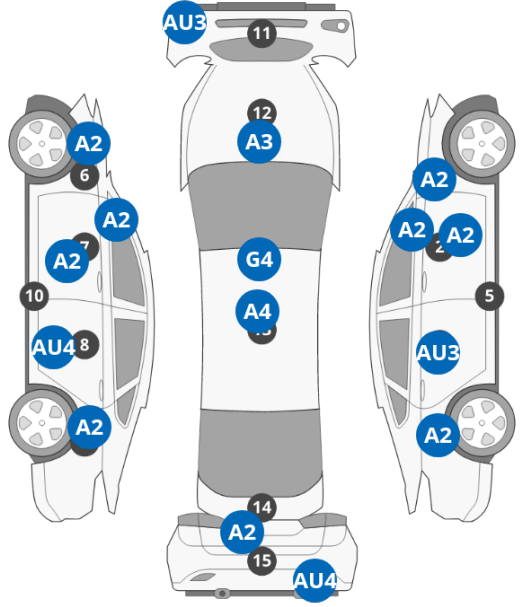
| Inspector Notes |
|---|
| <p>Scratch on front windshield. Scratches on taillights. With warranty booklet and jack. Without spare tire, tools, and seat cover. 1 key. With LTO plate.</p> |
