## General Information

| Make | Toyota | Model | Innova |

## Body / Panel Condition

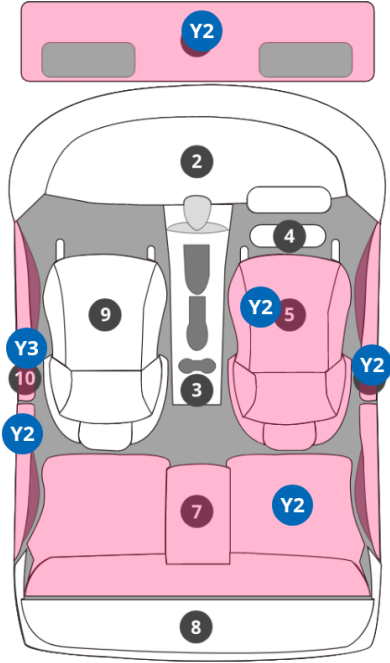
| Interior Evaluation : <b>B</b> | Exterior Evaluation : <b>D</b> |
| <b>Remarks</b><br>Ceiling - Grime - Small / (R) Front Trim - Grime - Small / (R) Front Seat - Grime - Small / Rear Seat - Grime - Small / Trim Other - Grime - Small / (L) Front Trim - Grime - Medium | <b>Remarks</b><br>(L) Rear Fender, Molding - Scratch & Dent - Medium / (L) Rear Door, Molding - Scratch - Small / (L) Mirror - Scratch - Small / (L) Front Door, Molding - Scratch - Small / (L) Front Fender, Molding - Scratch - Small / Front Bumper, Grille, Lamps - Scratch - Small / (R) Front Fender, Molding - Scratch & Dent - Minimal / (R) Mirror - Scratch - Small / (R) Rear Door, Molding - Scratch & Dent - Large / (R) Front Door, Molding - Scratch - Minimal / (R) Rear Fender, Molding - Scratch - Small / Rear Bumper, Lamps, Panels - Scratch & Dent - Large / Trunk Hood, Rear Gate - Scratch - Minimal |

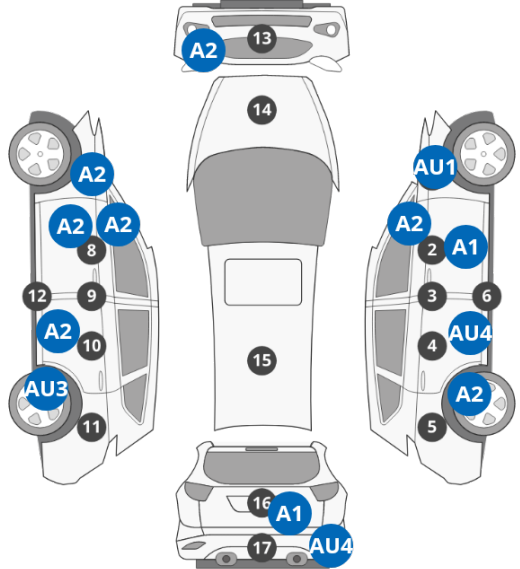
Gap at front bumper. Without warranty booklet. With Spare tire,jack,tools and seat cover. 2 keys. With LTO plate.
