## General Information

| Make | Toyota | Model | Vios |

## Body / Panel Condition

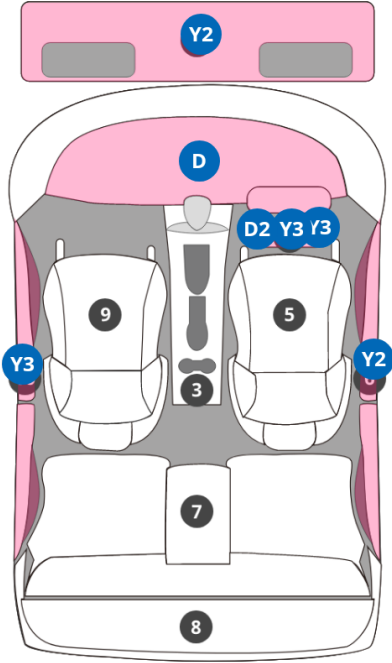
| Interior Evaluation : <span style="color: red;">C</span> | Exterior Evaluation : <span style="color: red;">C</span> |
| <p><b>Remarks</b><br/>Ceiling - Grime - Small / (R) Front Trim - Grime - Small / (R) Front Floor Mat - Grime - Medium / Dashboard - Traces of Adhesive Tape - Yes / Mat Other - Grime - Medium / (L) Front Trim - Grime - Medium / (L) Front Floor Mat - Worked - Small</p> | <p><b>Remarks</b><br/>(R) Front Door, Molding - Scratch - Large / (R) Rear Door, Molding - Scratch - Large / Rear Bumper, Lamps, Panels - Scratch - Small / (L) Rear Door, Molding - Scratch - Small / Trunk Hood, Rear Gate - Scratch - Small / (L) Mirror - Scratch - Minimal / (L) Front Door, Molding - Scratch - Small / (L) Front Fender, Molding - Scratch - Small / Front Bumper, Grille, Lamps - Scratch &amp; Dent - Medium / (R) Front Fender, Molding - Scratch - Small / (R) Mirror - Scratch - Minimal</p> |
