## General Information

| Make | Toyota | Model | Vios |
| YOM | 2023 | Odo Meter Reading | 31,966 |
| Registration No. | NIN2612 | Chassis No. | PA1B18F39P4208214 |

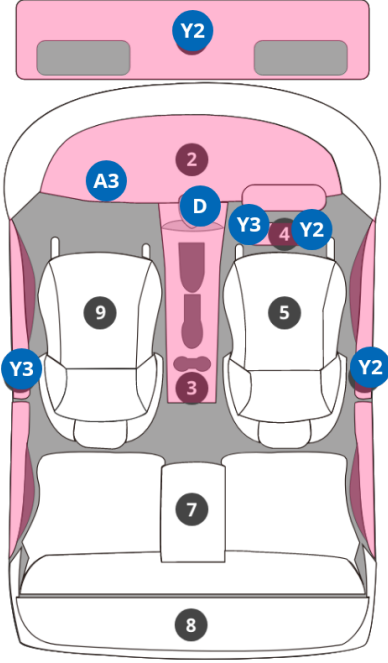
| Interior Evaluation : <span style="color: red;">C</span> | Exterior Evaluation : <span style="color: red;">E</span> |
| <p><b>Remarks</b><br/>Ceiling - Grime - Small / (R) Front Trim - Grime - Small / (R) Front Floor Mat - Grime - Small / (L) Front Trim - Grime - Medium / (L) Front Floor Mat - Grime - Medium / Console, Switchs, Vents - Traces of Adhesive Tape - Yes / Glove Box - Worn, Scratch, Cut, Crack - Medium</p> | <p><b>Remarks</b><br/>(L) Rear Fender - Repair Traces - Yes / (L) Front Door, Molding - Scratch &amp; Dent - Large / (L) Rear Door, Molding - Scratch - Medium / (L) Rear Fender, Molding - Repair mark - Yes / (L) Rear Fender, Molding - Scratch - Medium / Rear Bumper, Lamps, Panels - Scratch &amp; Dent - Large / Trunk Hood, Rear Gate - Scratch - Small / (R) Rear Fender, Molding - Scratch &amp; Dent - Medium / (R) Rear Door, Molding - Scratch - Medium / (R) Front Door, Molding - Scratch - Large / (R) Front Fender, Molding - Scratch - Medium / (R) Mirror - Scratch - Small / Front Bumper, Grille, Lamps - Scratch &amp; Dent - Large / (L) Mirror - Scratch - Minimal / (L) Front Fender, Molding - Scratch - Large / Roof - Scratch - Small</p> |
