## General Information

| Make | Toyota | Model | Wigo |

## Body / Panel Condition

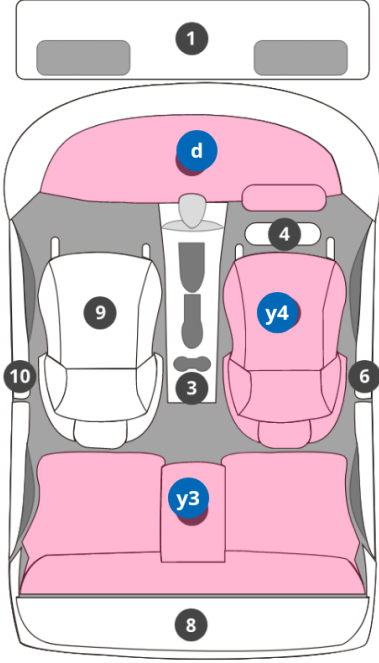
| Interior Evaluation : <span style="color: red; font-weight: bold;">C</span> | Exterior Evaluation : <span style="color: red; font-weight: bold;">B</span> |
|---|---|
| <p><b>Remarks</b><br/>Dashboard - Traces of Adhesive Tape - Yes / Rear Seat - Grime - Medium / (R) Front Seat - Grime - Large</p> | <p><b>Remarks</b><br/>Front Bumper, Grille, Lamps - Scratch - Medium / (L) Front Door, Molding - Scratch - Minimal / Trunk Hood, Rear Gate - Scratch - Minimal / (R) Front Door, Molding - Scratch - Minimal</p> |

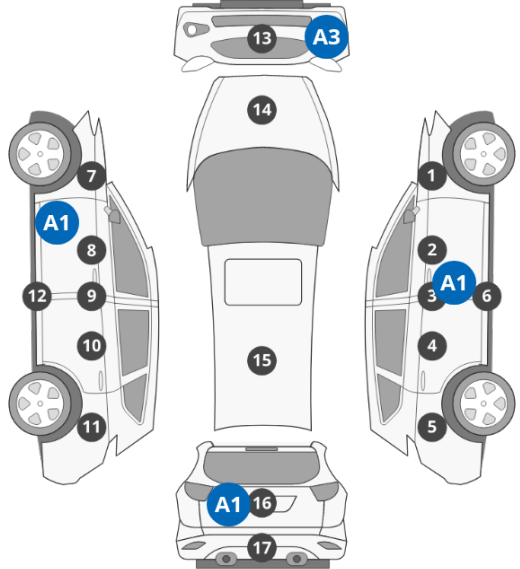
hairline scratches around the exterior.
