## General Information

| Make | Toyota | Model | Vios |
| Registration No. | DBB5700 | Chassis No. | PA1B18F32P4200987 |

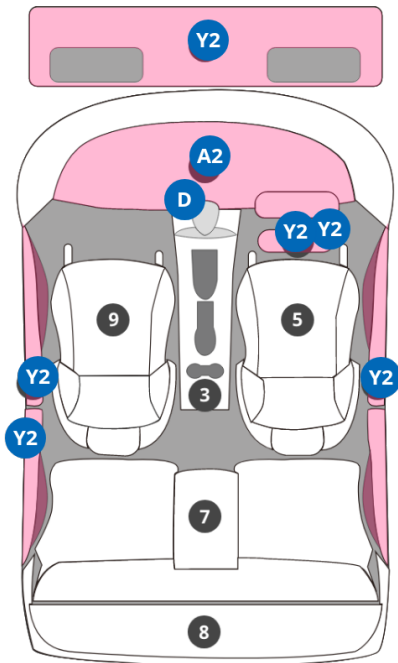
| <b>Remarks</b><br>Ceiling - Grime - Small / (R) Front Trim - Grime - Small / (R) Front Floor Mat - Grime - Small / (L) Rear Trim - Grime - Small / Mat Other - Grime - Small / (L) Front Trim - Grime - Small / Dashboard - Worn, Scratch, Cut, Crack - Small / Dashboard - Traces of Adhesive Tape - Yes | <b>Remarks</b><br>(L) Mirror - Scratch - Minimal / (L) Front Fender, Molding - Scratch & Dent - Small / (L) Rear Door, Molding - Scratch - Small / (R) Rear Fender, Molding - Scratch & Dent - Small / (R) Rear Door, Molding - Scratch - Minimal / (R) Front Fender, Molding - Scratch - Minimal / Front Bumper, Grille, Lamps - Scratch - Small / Trunk Hood, Rear Gate - Dent - Small / Rear Bumper, Lamps, Panels - Scratch & Dent - Medium / (R) Front Door, Molding - Scratch & Dent - Small / Roof - Dent - Small |
