## General Information

| Make | Toyota | Model | Vios |

## Body / Panel Condition

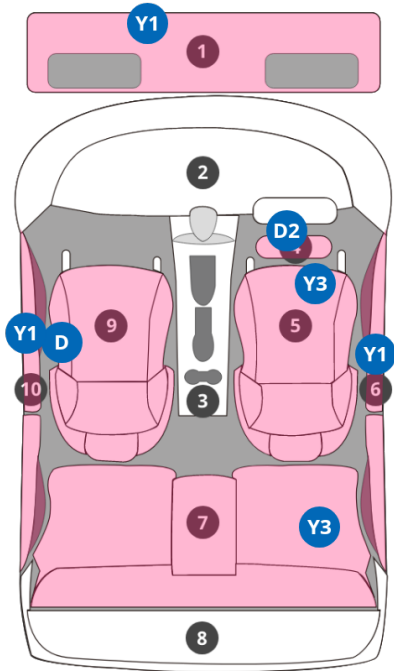
| Interior Evaluation : <span style="color: red; font-weight: bold;">B</span> | | Exterior Evaluation : <span style="color: red; font-weight: bold;">C</span> | |
|---|--|---|--|
| <p><b>Remarks</b></p> <p>Rear Seat - Grime - Medium / (R) Front Seat - Grime - Medium / (L) Front Seat - Worn - Yes / (R) Front Trim - Grime - Minimal / (L) Front Trim - Grime - Minimal / (L) Front Floor Mat - Worked - Small / Ceiling - Grime - Minimal</p> | | <p><b>Remarks</b></p> <p>(R) Mirror - Scratch - Minimal / (R) Front Fender, Molding - Scratch - Minimal / (R) Front Door, Molding - Scratch - Minimal / (R) Rear Door, Molding - Scratch - Minimal / (R) Rear Fender, Molding - Scratch - Minimal / Rear Bumper, Lamps, Panels - Scratch &amp; Dent - Small / Trunk Hood, Rear Gate - Dent - Small / (L) Rear Fender, Molding - Scratch - Small / (L) Front Door, Molding - Scratch - Small / (L) Rear Door, Molding - Scratch - Minimal / (L) Mirror - Scratch - Small / (L) Front Fender, Molding - Scratch - Minimal / Member (Bolted) - Dent - Yes / Front Bumper, Grille, Lamps - Scratch - Small / Bonnet, Headlight - Scratch - Small / Roof - Scratch - Minimal</p> | |

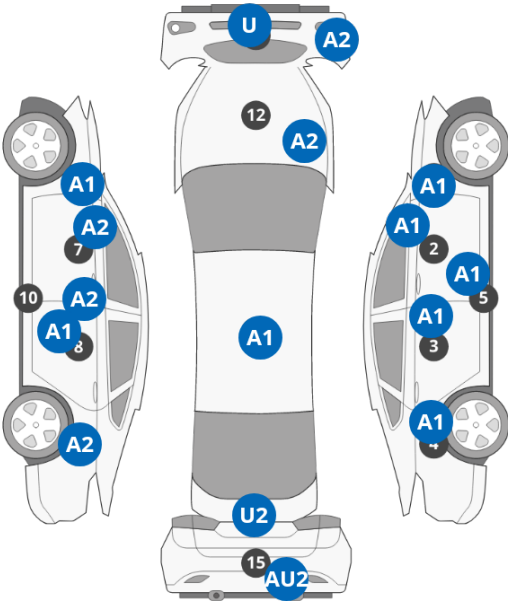
no warranty booklet, with jack, no tools, with spare tire, with LTO plate, scratches on tail light
