## General Information

| Make | Toyota | Model | Vios |
| Registration No. | NEY2870 | Chassis No. | PA1B18F38R4251817 |

## Body / Panel Condition

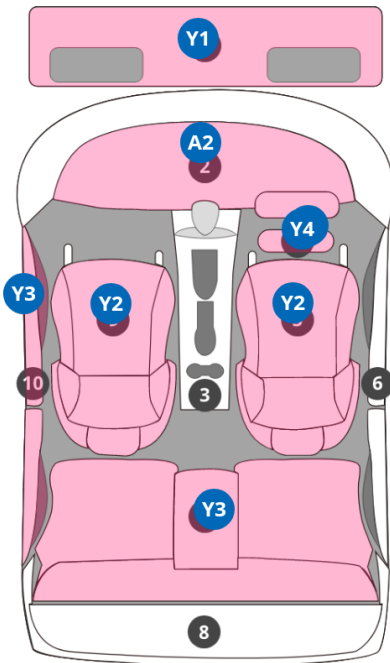
| Interior Evaluation : <span style="color: red;">C</span> | Exterior Evaluation : <span style="color: red;">D</span> |
|---|---|
| <b>Remarks</b><br>(R) Front Seat - Grime - Small / Rear Seat - Grime - Medium / (L) Front Trim - Grime - Medium / (L) Front Floor Mat - Grime - Small / (L) Front Seat - Grime - Small / Dashboard - Worn, Scratch, Cut, Crack - Small / Ceiling - Grime - Minimal / Mat Other - Grime - Large | <b>Remarks</b><br>(R) Front Fender, Molding - Dent - Small / (R) Front Door, Molding - Dent - Large / (L) Front Fender, Molding - Scratch & Dent - Large / Front Bumper, Grille, Lamps - Scratch & Dent - Medium / (L) Front Door, Molding - Scratch & Dent - Small / (L) Mirror - Crack - Damaged / (L) Rear Fender, Molding - Dent - Small / (L) Rear Door, Molding - Dent - Minimal / (R) Rear Fender, Molding - Scratch & Dent - Small / (R) Rear Door, Molding - Scratch - Small / (R) Mirror - Scratch - Minimal |
