## General Information

| Make | Toyota | Model | Vios |

## Body / Panel Condition

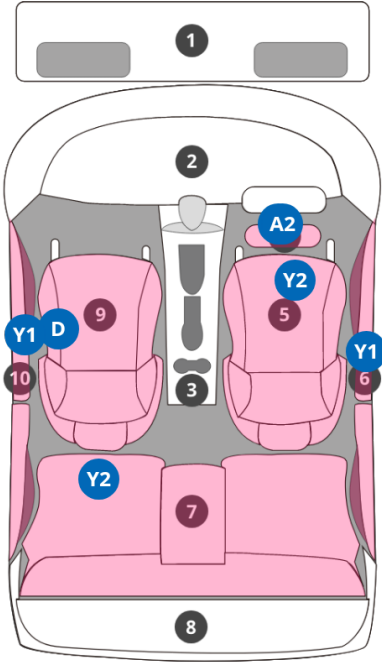
| Interior Evaluation : <b>B</b> | Exterior Evaluation : <b>E</b> |
| <b>Remarks</b><br>(L) Front Seat - Worn - Yes / (L) Front Trim - Grime - Minimal / (R) Front Trim - Grime - Minimal / (L) Front Floor Mat - Cut, Crack - Medium / Carpet - Worn, Scratch, Cut, Crack - Small / Rear Seat - Grime - Small / (R) Front Seat - Grime - Small | <b>Remarks</b><br>(R) Front Fender, Molding - Scratch - Small / (R) Mirror - Scratch - Minimal / (R) Front Door, Molding - Scratch - Small / (R) Rear Door, Molding - Scratch - Small / (R) Rear Fender, Molding - Scratch - Small / Rear Bumper, Lamps, Panels - Scratch & Dent - Large / Trunk Hood, Rear Gate - Scratch & Dent - Medium / (L) Rear Fender, Molding - Scratch - Small / (L) Rear Door, Molding - Scratch & Dent - Large / (L) Front Door, Molding - Scratch - Small / (L) Front Fender, Molding - Scratch - Small / Member (Bolted) - Dent - Yes / Front Bumper, Grille, Lamps - Scratch - Large / Bonnet, Headlight - Scratch - Small / (L) Mirror - Scratch - Small / Roof - Scratch - Small |
