## General Information

| Make | Toyota | Model | Lite Ace |
| Registration No. | NHI8700 | Chassis No. | MHKU3FE10PK003755 |

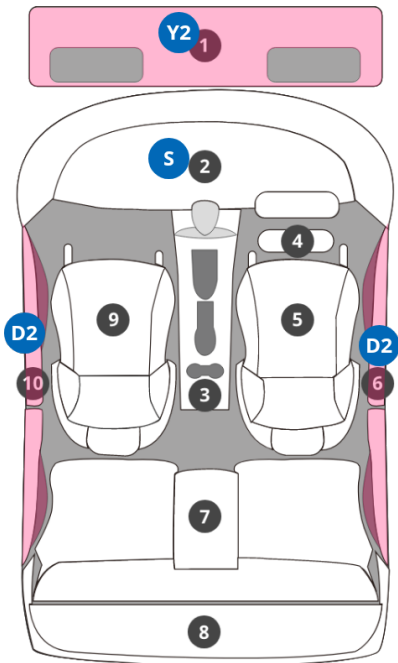
| Interior Evaluation : <b>B</b> | Exterior Evaluation : <b>C</b> |
|---|---|
| <p><b>Remarks</b><br/>(L) Front Trim - Worked - Small / (R) Front Trim - Worked - Small / Overall Interior - Smell - Yes / Ceiling - Grime - Small</p> | <p><b>Remarks</b><br/>(L) Side Gate - Scratch &amp; Dent - Small / (R) Side Gate - Scratch &amp; Dent - Medium / Rear Bumper, Lamps, Panels - Modified - Medium / Roof - Dent - Large / Rear Gate - Scratch &amp; Dent - Small / Bonnet, Headlight - Dent - Small / (R) Front Door, Molding - Scratch &amp; Dent - Small / Front Bumper, Grille, Lamps - Scratch - Small / (L) Front Door, Molding - Scratch &amp; Dent - Small / (L) Front Fender, Molding - Scratch - Small / (R) Front Fender, Molding - Scratch &amp; Dent - Small</p> |
