## General Information

| Make | Toyota | Model | Vios |
| YOM | 2023 | Odo Meter Reading | 7,903 |
| Registration No. | NHJ1504 | Chassis No. | PA1B18F30P4216024 |

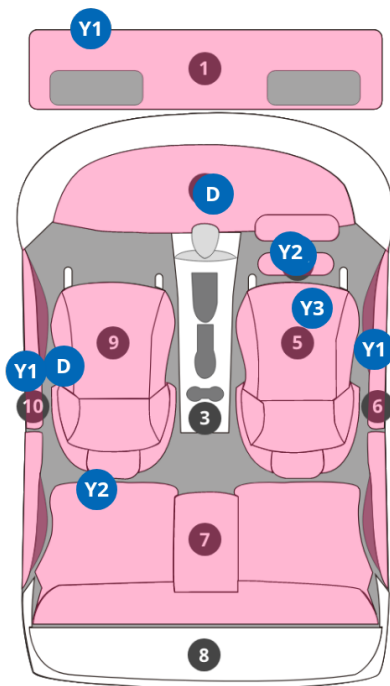
| Interior Evaluation : <b>B</b> | Exterior Evaluation : <b>E</b> |
| <p><b>Remarks</b></p> <p>Rear Seat - Grime - Small / (R) Front Seat - Grime - Medium / (L) Front Seat - Worn - Yes / (R) Front Trim - Grime - Minimal / (L) Front Trim - Grime - Minimal / (L) Front Floor Mat - Worked - Small / (L) Front Floor Mat - Grime - Small / Dashboard - Traces of Adhesive Tape - Yes / Ceiling - Grime - Minimal</p> | <p><b>Remarks</b></p> <p>(R) Mirror - Scratch - Small / (R) Front Fender, Molding - Scratch &amp; Dent - Small / (R) Front Door, Molding - Scratch - Small / (R) Rear Fender, Molding - Scratch - Small / (R) Rear Door, Molding - Scratch - Small / Rear Bumper, Lamps, Panels - Scratch - Small / Trunk Hood, Rear Gate - Scratch - Small / (L) Rear Fender, Molding - Scratch &amp; Dent - Large / (L) Rear Door, Molding - Scratch &amp; Dent - Large / (L) Front Door, Molding - Scratch &amp; Dent - Medium / (L) Step, In-panel, Side Spoiler - Scratch &amp; Dent - Small / (L) Mirror - Scratch - Minimal / (L) Front Fender, Molding - Dent - Medium / Member (Bolted) - Dent - Yes / Front Bumper, Grille, Lamps - Scratch - Medium / Bonnet, Headlight - Scratch - Minimal / Roof - Scratch - Small</p> |

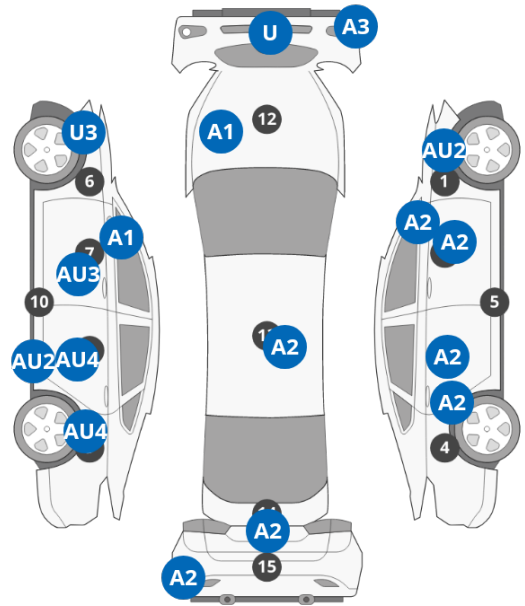
| Inspector Notes |
|---|
| no warranty booklet, with jack and tools, with spare tire, with LTO plate, scratches on tail light |
