General Information

Make	Hyundai	Model	Elantra
YOM	2019	Odo Meter Reading	69,991
Registration No.	NEH3987	Chassis No.	KMHD741CAJU649475
CC	1.6	Transmission	A/T
Fuel Type	Gas	Type of Body	Sedan
Colour	Blue

Body / Panel Condition

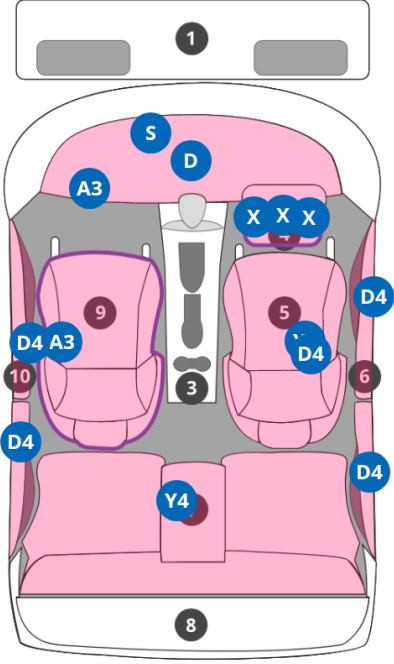
Interior Evaluation : E	Exterior Evaluation : E

<p>a : Cut, Fray d : Loose, Deformed k : Animal Hair s : Smell t : Cigarette Burns x : Defective y : Stain</p>

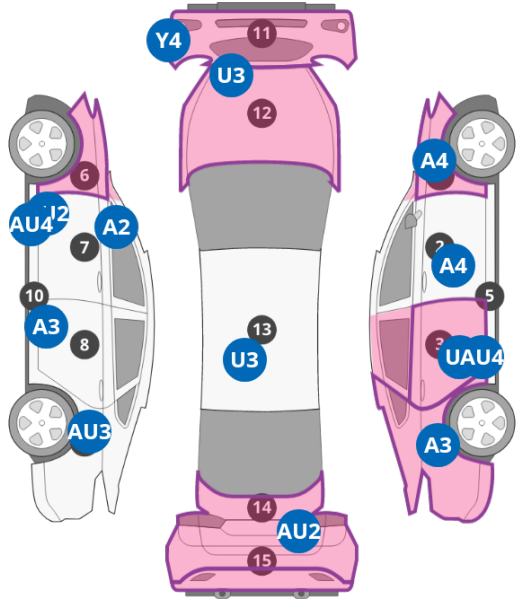
<p>A : Scratch AU : Scratch & Dent B : Modified C : Corrosion G : Stone chip P : Faded S : Rust SC : Rust & Corrosion U : Dent X : Defective Y : Crack, Gap</p>
<p>Remarks (R) Front Floor Mat - Missing - Yes / (L) Front Floor Mat - Missing - Yes / Mat Other - Missing - Yes / Steering Wheel - Worn, Peel, Crack - Medium / (L) Front Seat - Cut, Crack - Medium / (L) Front Seat Knobs - Partially Missing - Yes / (L) Front Seat Knobs - Stuck - Yes / (L) Front Trim - Worked - Large / (L) Rear Trim - Worked - Large / Rear Seat - Grime - Large / (R) Rear Trim - Worked - Large / (R) Front Trim - Worked - Large / (R) Front Seat - Grime - Large / (R) Front Seat belt - Loose, Deformed - Large / Dashboard - Traces of Adhesive Tape - Yes / Overall Interior - Smell - Yes</p>	<p>Remarks (R) Front Door - Repair Traces - Yes / (R) Step - Repair Traces - Yes / (R) Front Fender - Repair Traces - Yes / Bonnet - Repair Traces - Yes / (L) Front Fender - Repair Traces - Yes / (L) Front Door - Repair Traces - Yes / (L) Step - Repair Traces - Yes / (L) Rear Door - Repair Traces - Yes / (L) Rear Fender - Repair Traces - Yes / Trunk Hood, Rear Gate - Repair Traces - Yes / (R) Rear Fender - Repair Traces - Yes / (R) Rear Door - Repair Traces - Yes / Roof - Repair Traces - Yes / Rear Bumper, Lamps, Panels - Repair mark - Difference in Color / Trunk Hood, Rear Gate - Repair mark - Yes / Trunk Hood, Rear Gate - Scratch & Dent - Small / (R) Rear Fender, Molding - Repair mark - Yes / (R) Rear Fender, Molding - Scratch - Medium / (R) Rear Door, Molding - Partially Missing - Yes / (R) Rear Door, Molding - Repair mark - Yes / (R) Rear Door, Molding - Dent - Large / (R) Step, In-panel, Side Spoiler - Scratch & Dent - Large / (R) Front Door, Molding - Scratch - Large / (R) Front Fender, Molding - Scratch - Large / Front Bumper, Grille, Lamps - Repair mark - Difference in Color / (R) Front Fender, Molding - Repair mark - Yes / Front Bumper, Grille, Lamps - Crack, Gap - Large / (L) Front Fender, Molding - Repair mark - Yes / Bonnet, Headlight - Repair mark - Yes / Bonnet, Headlight - Dent - Medium / (L) Mirror - Scratch - Small / (L) Front Door, Molding - Scratch & Dent - Small / (L) Step, In-panel, Side Spoiler - Scratch & Dent - Large / (L) Rear Door, Molding - Scratch - Medium / (L) Rear Fender, Molding - Scratch & Dent - Medium / Roof - Dent - Medium</p>
