## General Information

| Make | Toyota | Model | Vios |

## Body / Panel Condition

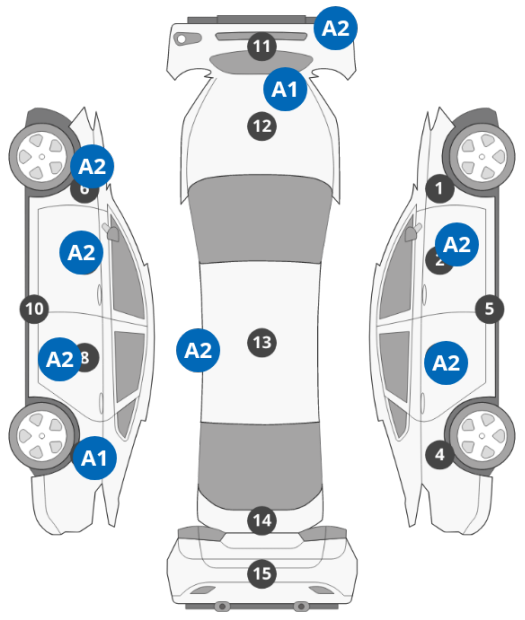
| Interior Evaluation : <span style="color: red; font-weight: bold;">A</span> | Exterior Evaluation : <span style="color: red; font-weight: bold;">B</span> |
| <b>Remarks</b><br>Defects not found | <b>Remarks</b><br>Front Bumper, Grille, Lamps - Scratch - Small / (L) Front Fender, Molding - Scratch - Small / (L) Front Door, Molding - Scratch - Small / (L) Rear Door, Molding - Scratch - Small / (L) Rear Fender, Molding - Scratch - Minimal / (R) Rear Door, Molding - Scratch - Small / (R) Front Door, Molding - Scratch - Small / Bonnet, Headlight - Scratch - Minimal / Roof - Scratch - Small |

| Inspector Notes |
|---|
| swirlmarks and hairline scratches around the exterior.with manual and warranty booklet.no tools. |
