## General Information

| Make | Toyota | Model | Lite Ace |
| Registration No. | NHN6391 | Chassis No. | MHKB3FE10RK003873 |

## Body / Panel Condition

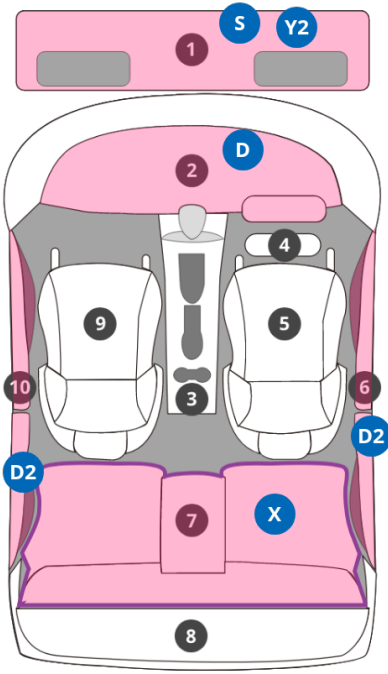
| Interior Evaluation : <b>B</b> | Exterior Evaluation : <b>C</b> |
| <p><b>Remarks</b></p> <p>Rear Seat - Missing - Yes / Trim Other - Worked - Small / Trim Other - Worked - Small / Overall Interior - Smell - Yes / Ceiling - Grime - Small / Dashboard - Traces of Adhesive Tape - Yes</p> | <p><b>Remarks</b></p> <p>Trunk Hood, Rear Gate - Scratch &amp; Dent - Medium / Rear Bumper, Lamps, Panels - Scratch - Small / (L) Rear Fender, Molding - Repair mark - Yes / (L) Rear Fender, Molding - Scratch - Small / (L) Step, In-panel, Side Spoiler - Scratch &amp; Dent - Small / (L) Rear Door, Molding - Scratch - Small / (L) Front Door, Molding - Scratch - Minimal / (L) Front Fender, Molding - Scratch - Small / Bonnet, Headlight - Scratch - Minimal / (R) Front Fender, Molding - Scratch - Minimal / Front Bumper, Grille, Lamps - Scratch - Small / (R) Front Door, Molding - Scratch - Small / (R) Rear Door, Molding - Scratch - Minimal / (R) Step, In-panel, Side Spoiler - Scratch &amp; Dent - Small / (R) Rear Fender, Molding - Scratch - Small / Roof - Scratch &amp; Dent - Small</p> |
