## General Information

| Make | Toyota | Model | Vios |
| Registration No. | NHR4339 | Chassis No. | PA1B18F38P4230124 |

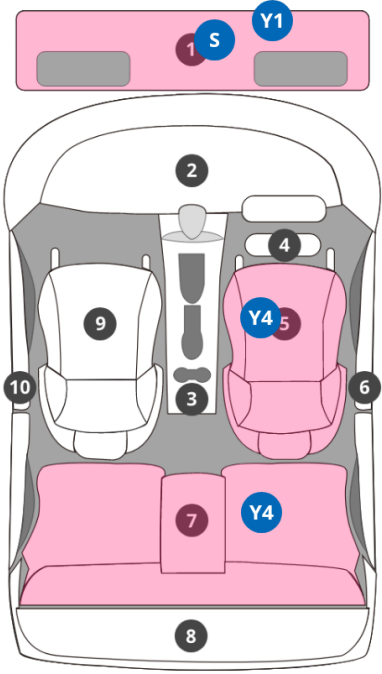
| Interior Evaluation : <span style="color: red;">C</span> | Exterior Evaluation : <span style="color: red;">C</span> |
| <b>Remarks</b><br>Overall Interior - Smell - Yes / Rear Seat - Grime - Large / (R) Front Seat - Grime - Large / Ceiling - Grime - Minimal | <b>Remarks</b><br>Member (Bolted) - Dent - Yes / (L) Front Fender, Molding - Scratch - Small / (R) Front Door, Molding - Scratch & Dent - Small / (R) Rear Fender, Molding - Dent - Minimal / (R) Rear Door, Molding - Scratch & Dent - Small / Trunk Hood, Rear Gate - Scratch & Dent - Small / Rear Bumper, Lamps, Panels - Scratch - Small / (L) Rear Fender, Molding - Scratch - Small / Roof - Scratch - Small / Bonnet, Headlight - Scratch & Dent - Small / (R) Step, In-panel, Side Spoiler - Scratch & Dent - Minimal / (L) Step, In-panel, Side Spoiler - Scratch - Minimal / (L) Rear Door, Molding - Scratch - Minimal / (L) Front Door, Molding - Scratch - Minimal / (R) Front Fender, Molding - Scratch & Dent - Small / Front Bumper, Grille, Lamps - Crack, Gap - Small |
