## General Information

| Make | Toyota | Model | Avanza |

## Body / Panel Condition

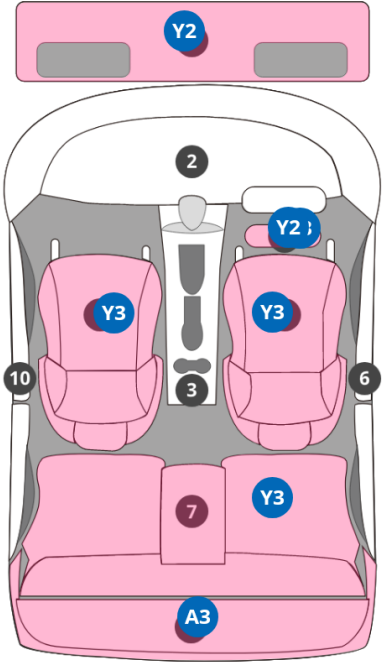
| Interior Evaluation : <span style="color: red;">C</span> | Exterior Evaluation : <span style="color: red;">C</span> |
| <b>Remarks</b><br>Trunk Room - Worn, Scratch, Cut, Crack - Medium / Rear Seat - Grime - Medium / (R) Front Seat - Grime - Medium / (R) Front Floor Mat - Grime - Medium / (L) Front Floor Mat - Grime - Small / (L) Front Seat - Grime - Medium / Ceiling - Grime - Small | <b>Remarks</b><br>(L) Rear Fender, Molding - Scratch & Dent - Small / (L) Rear Door, Molding - Scratch - Small / Front Bumper, Grille, Lamps - Scratch - Large / Rear Bumper, Lamps, Panels - Scratch & Dent - Small / Trunk Hood, Rear Gate - Scratch - Minimal / (R) Rear Fender, Molding - Scratch - Medium / (R) Rear Door, Molding - Scratch & Dent - Small / (R) Front Fender, Molding - Scratch & Dent - Medium / (R) Mirror - Scratch - Small / (R) Front Door, Molding - Scratch - Minimal / Roof - Scratch - Minimal |
