## General Information

| Make | Toyota | Model | Avanza |

## Body / Panel Condition

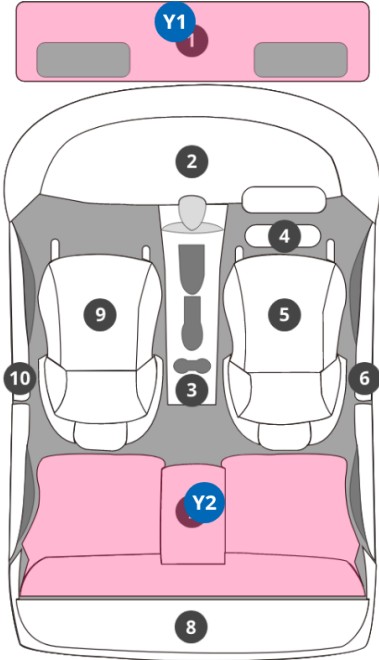
| Interior Evaluation : <b>A</b> | Exterior Evaluation : <b>B</b> |
| <p><b>Remarks</b><br/>Ceiling - Grime - Minimal / Rear Seat - Grime - Small</p> | <p><b>Remarks</b><br/>(R) Front Door, Molding - Dent - Minimal / (R) Rear Door, Molding - Scratch - Small / (R) Step, In-panel, Side Spoiler - Scratch - Minimal / (R) Rear Fender, Molding - Scratch - Minimal / Rear Bumper, Lamps, Panels - Scratch &amp; Dent - Small / Trunk Hood, Rear Gate - Scratch - Minimal / (L) Rear Fender, Molding - Scratch - Minimal / (L) Rear Door, Molding - Scratch - Minimal / (L) Front Door, Molding - Scratch - Minimal / (L) Front Fender, Molding - Scratch - Minimal / Front Bumper, Grille, Lamps - Scratch - Minimal / Bonnet, Headlight - Scratch - Minimal / Roof - Scratch - Minimal / (R) Front Fender, Molding - Scratch - Minimal</p> |
