## General Information

| Make | Toyota | Model | Wigo |
| YOM | 2024 | Odo Meter Reading | 8,130 |
| Registration No. | DBM4519 | Chassis No. | MHKAA1BC5RJ014519 |

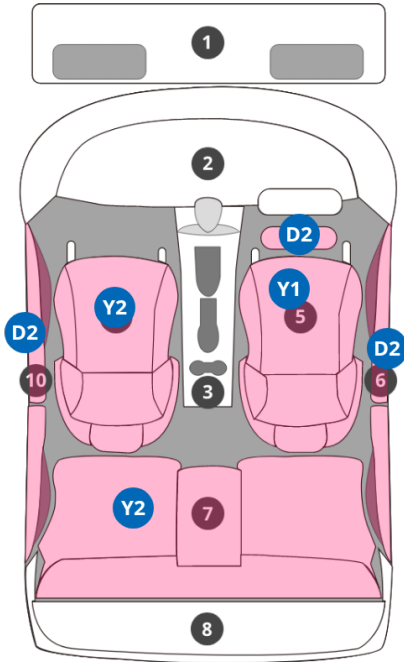
| Interior Evaluation : <b>B</b> | Exterior Evaluation : <b>B</b> |
| <b>Remarks</b><br>Rear Seat - Grime - Small / (L) Front Floor Mat - Worked - Small / (L) Front Trim - Worked - Small / (R) Front Trim - Worked - Small / (R) Front Seat - Grime - Minimal / (L) Front Seat - Grime - Small | <b>Remarks</b><br>(L) Front Door, Molding - Scratch - Small / (L) Rear Door, Molding - Scratch - Minimal / (L) Front Fender, Molding - Scratch - Minimal / (L) Rear Fender, Molding - Scratch & Dent - Minimal / Bonnet, Headlight - Scratch - Small / Front Bumper, Grille, Lamps - Scratch - Small / (R) Front Fender, Molding - Scratch - Small / (R) Front Door, Molding - Scratch - Minimal / (R) Rear Door, Molding - Scratch - Minimal / (R) Rear Fender, Molding - Scratch - Minimal / Roof - Scratch - Minimal / Trunk Hood, Rear Gate - Scratch - Minimal / Rear Bumper, Lamps, Panels - Scratch - Minimal |

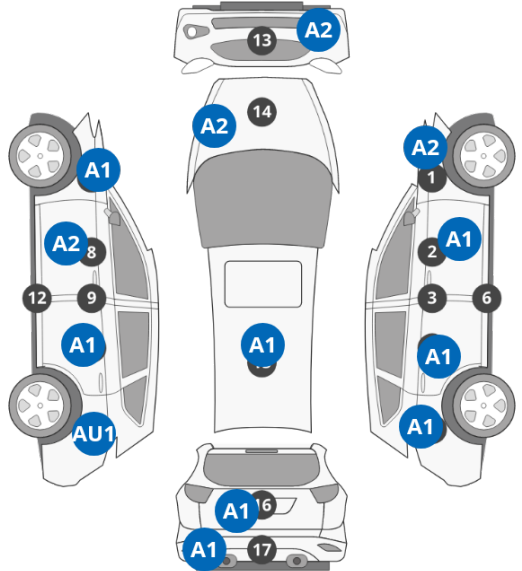
| Inspector Notes |
|---|
| With LTO plate and warranty booklet and Sparetire and Jack, Incomplete Tools. Scratch headlight and tail light. |
