## General Information

| Make | Toyota | Model | Vios |
| YOM | 2025 | Odo Meter Reading | 15,194 |

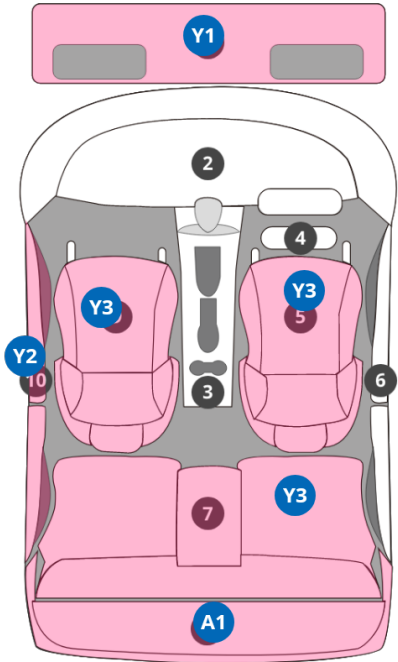
| Interior Evaluation : <b>B</b> | Exterior Evaluation : <b>C</b> |
|---|---|
| <p><b>Remarks</b><br/>Trunk Room - Worn, Scratch, Cut, Crack - Minimal / Rear Seat - Grime - Medium / (R) Front Seat - Grime - Medium / Ceiling - Grime - Minimal / (L) Front Seat - Grime - Medium / (L) Front Trim - Grime - Small</p> | <p><b>Remarks</b><br/>(R) Front Fender, Molding - Scratch - Minimal / (R) Front Door, Molding - Scratch - Minimal / (R) Rear Door, Molding - Scratch - Small / (R) Rear Fender, Molding - Scratch - Minimal / Rear Bumper, Lamps, Panels - Scratch - Small / Trunk Hood, Rear Gate - Scratch - Minimal / (L) Rear Fender, Molding - Scratch &amp; Dent - Small / (L) Rear Door, Molding - Scratch - Small / (L) Step, In-panel, Side Spoiler - Scratch - Medium / (L) Front Door, Molding - Scratch - Minimal / Roof - Scratch - Minimal / Front Bumper, Grille, Lamps - Crack, Gap - Medium / Bonnet, Headlight - Scratch - Minimal / (L) Front Fender, Molding - Scratch - Minimal</p> |
