## General Information

| Make | Toyota | Model | Rush |
| YOM | 2023 | Mileage | 24,736 |
| Registration No. | NIN1653 | Chassis No. | MHKE8FF3PPK053330 |

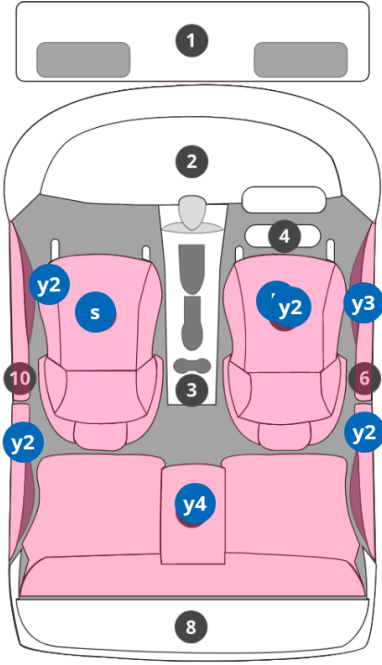
| Interior Evaluation : <span style="color: red;">C</span> | Exterior Evaluation : <span style="color: red;">B</span> |
| <p><b>Remarks</b><br/> Rear Seat - Grime - Large / (L) Rear Trim - Grime - Small / (R) Rear Trim - Grime - Small / (R) Front Trim - Grime - Medium / Overall Interior - Animal Hair - Yes / Overall Interior - Smell - Yes / (R) Front Seat - Grime - Small / (L) Front Seat - Grime - Small / Overall Interior - Worn as per age - Yes</p> | <p><b>Remarks</b><br/> (L) Front Door, Molding - Scratch &amp; Dent - Medium / (R) Mirror - Scratch - Minimal / Trunk Hood, Rear Gate - Scratch - Medium / Rear Bumper, Lamps, Panels - Scratch - Minimal</p> |
