## General Information

| Make | Toyota | Model | Wigo |
| YOM | 2024 | Odo Meter Reading | 7,549 |

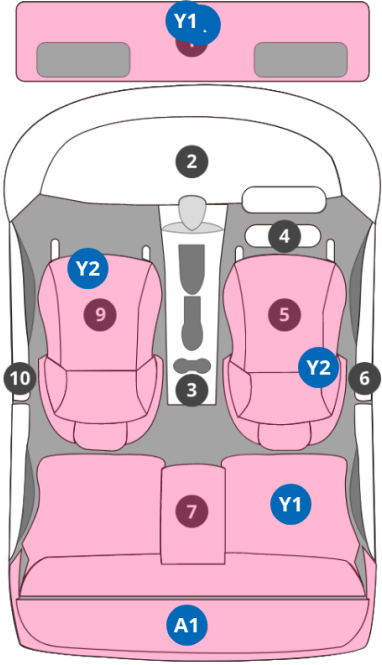
| Interior Evaluation : <b>B</b> | Exterior Evaluation : <b>C</b> |
|---|---|
| <p><b>Remarks</b><br/>Trunk Room - Worn, Scratch, Cut, Crack - Minimal / Overall Interior - Animal Hair - Yes / (R) Front Seat - Grime - Small / Rear Seat - Grime - Minimal / Ceiling - Grime - Minimal / (L) Front Seat - Grime - Small</p> | <p><b>Remarks</b><br/>(R) Front Fender, Molding - Scratch - Minimal / (R) Front Door, Molding - Scratch - Minimal / (R) Rear Door, Molding - Scratch - Medium / (R) Rear Fender, Molding - Scratch - Medium / Rear Bumper, Lamps, Panels - Scratch - Minimal / Trunk Hood, Rear Gate - Scratch - Minimal / (L) Rear Fender, Molding - Scratch - Minimal / (L) Rear Door, Molding - Scratch - Minimal / (L) Front Door, Molding - Scratch - Minimal / (L) Front Fender, Molding - Scratch - Small / Front Bumper, Grille, Lamps - Crack, Gap - Large / Bonnet, Headlight - Dent - Small / Roof - Scratch - Minimal</p> |

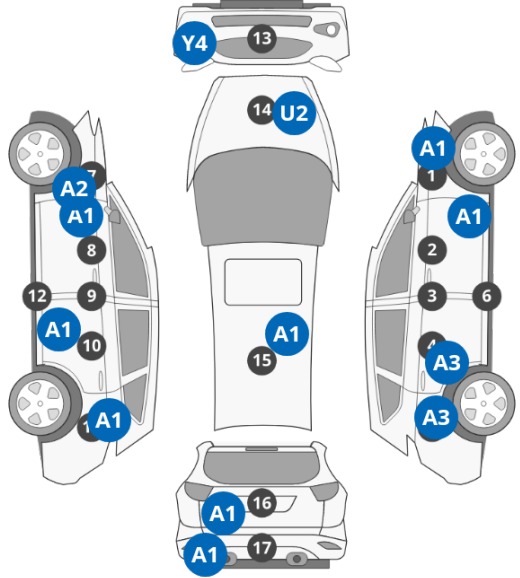
| Inspector Notes |
|---|
| with LTO plate, no warranty booklet, with jack and incomplete tools, with spare tire, scratches on tail light and headlights |
