General Information

Make	Nissan	Model	Juke
YOM	2018	Odo Meter Reading	59,148
Registration No.	NBF6379	Chassis No.	JNF1BAF15Z0600734
CC	1.6	Transmission	CVT
Fuel Type	Gas	Type of Body	SUV
Colour	Red

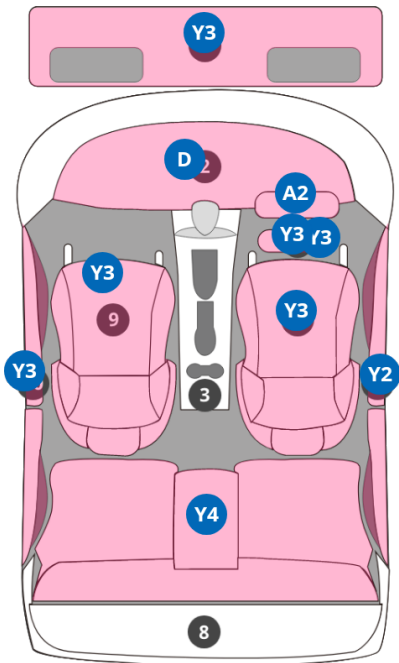
Interior Evaluation : D	Exterior Evaluation : C

<p>a : Cut, Fray d : Loose, Deformed k : Animal Hair s : Smell t : Cigarette Burns x : Defective y : Stain</p>

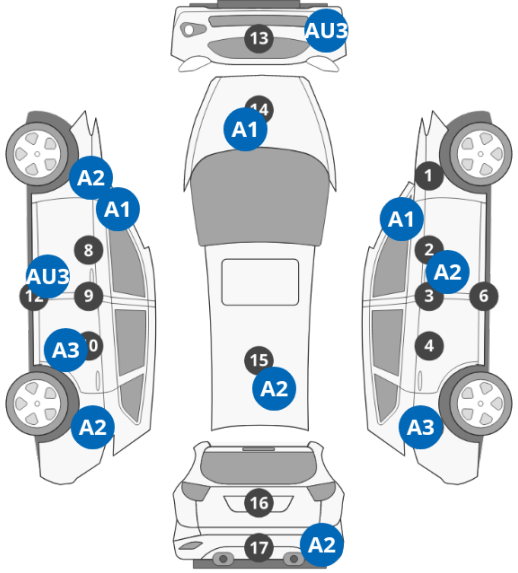
<p>A : Scratch AU : Scratch & Dent B : Modified C : Corrosion G : Stone chip P : Faded S : Rust SC : Rust & Corrosion U : Dent X : Defective Y : Crack, Gap</p>
<p>Remarks Ceiling - Grime - Medium / (R) Front Trim - Grime - Small / (R) Front Seat - Grime - Medium / (R) Front Floor Mat - Grime - Medium / Rear Seat - Grime - Large / Mat Other - Grime - Medium / (L) Front Trim - Grime - Medium / (L) Front Seat - Grime - Medium / Steering Wheel - Worn, Peel, Crack - Small / Dashboard - Traces of Adhesive Tape - Yes</p>	<p>Remarks (R) Front Fender - Repair Traces - Yes / (R) Rear Door - Repair Traces - Yes / (L) Front Door, Molding - Scratch & Dent - Medium / (L) Mirror - Scratch - Minimal / (L) Front Fender, Molding - Scratch - Small / Bonnet, Headlight - Scratch - Minimal / Front Bumper, Grille, Lamps - Scratch & Dent - Medium / (R) Mirror - Scratch - Minimal / (R) Front Door, Molding - Scratch - Small / (R) Rear Fender, Molding - Scratch - Medium / Rear Bumper, Lamps, Panels - Scratch - Small / (L) Rear Fender, Molding - Scratch - Small / (L) Rear Door, Molding - Scratch - Medium / Roof - Scratch - Small</p>
