## General Information

| Make | Toyota | Model | Vios |
| YOM | 2025 | Odo Meter Reading | 18,013 |
| Registration No. | NKL4658 | Chassis No. | PA1B18F35R4279350 |

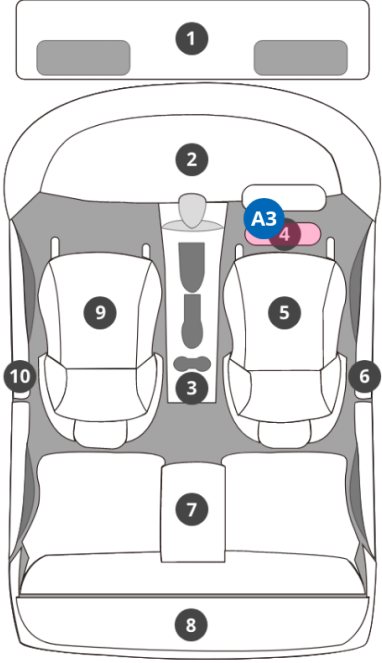
| Interior Evaluation : <b>B</b> | Exterior Evaluation : <b>E</b> |
|---|---|
| <b>Remarks</b><br>(L) Front Floor Mat - Cut, Crack - Medium | <b>Remarks</b><br>Trunk Hood, Rear Gate - Scratch & Dent - Large / Rear Bumper, Lamps, Panels - Scratch & Dent - Large / (L) Front Door, Molding - Repair mark - Difference in Color / (L) Front Door, Molding - Scratch & Dent - Medium / (L) Rear Door, Molding - Scratch - Small / (L) Step, In-panel, Side Spoiler - Scratch - Small / Front Bumper, Grille, Lamps - Scratch & Dent - Large / (R) Front Fender, Molding - Scratch - Small / (R) Front Door, Molding - Scratch & Dent - Large / (R) Rear Door, Molding - Scratch - Minimal / (R) Rear Fender, Molding - Scratch - Small / (R) Mirror - Scratch - Small / (L) Mirror - Scratch - Small / (L) Front Fender, Molding - Scratch - Small / (L) Rear Fender, Molding - Crack, Gap - Large |
