## General Information

<b>Make</b>	Toyota	<b>Model</b>	Vios
<b>YOM</b>	2025	<b>Odo Meter Reading</b>	15,581
<b>Registration No.</b>	CCJ2714	<b>Chassis No.</b>	PAB18F30R4276677
<b>CC</b>	1.3	<b>Transmission</b>	CVT
<b>Fuel Type</b>	Gas	<b>Type of Body</b>	Sedan
<b>Colour</b>	Blackish Red Mica

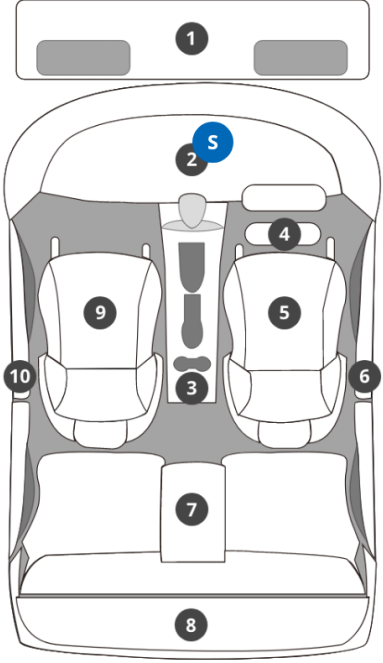
<b>Interior Evaluation :</b> <span style="float: right; color: red; font-weight: bold;">B</span>	<b>Exterior Evaluation :</b> <span style="float: right; color: red; font-weight: bold;">D</span>

<p><b>a</b> : Cut, Fray <b>d</b> : Loose, Deformed <b>k</b> : Animal Hair <b>s</b> : Smell <b>t</b> : Cigarette Burns <b>x</b> : Defective <b>y</b> : Stain</p>

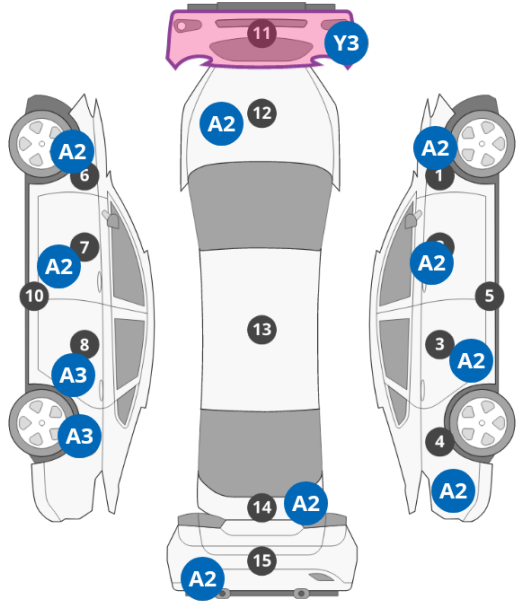
<p><b>A</b> : Scratch <b>AU</b> : Scratch &amp; Dent <b>B</b> : Modified <b>C</b> : Corrosion <b>G</b> : Stone chip <b>P</b> : Faded <b>S</b> : Rust <b>SC</b> : Rust &amp; Corrosion <b>U</b> : Dent <b>X</b> : Defective <b>Y</b> : Crack, Gap</p>
<p><b>Remarks</b> Overall Interior - Smell - Yes</p>	<p><b>Remarks</b> Front Bumper, Grille, Lamps - Crack, Gap - Medium / (L) Rear Fender, Molding - Scratch - Medium / (L) Rear Door, Molding - Scratch - Medium / (L) Front Door, Molding - Scratch - Small / Front Bumper, Grille, Lamps - Repair mark - Yes / (R) Rear Door, Molding - Scratch - Small / (R) Front Door, Molding - Scratch - Small / (R) Front Fender, Molding - Scratch - Small / (L) Front Fender, Molding - Scratch - Small / (R) Rear Fender, Molding - Scratch - Small / Rear Bumper, Lamps, Panels - Scratch - Small / Bonnet, Headlight - Scratch - Small / Trunk Hood, Rear Gate - Scratch - Small</p>
