## General Information

| Make | Toyota | Model | Vios |
| Registration No. | CCA9096 | Chassis No. | PA1B18F32R4260481 |

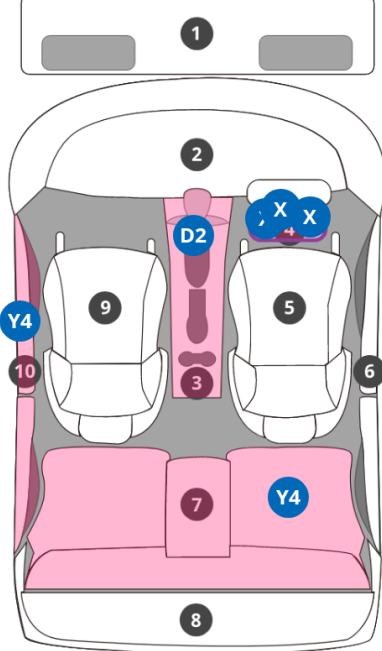
| Interior Evaluation : <b>C</b> | Exterior Evaluation : <b>E</b> |
| <p><b>Remarks</b><br/>Console, Switches, Vents - Loose, Deformed - Small / Rear Seat - Grime - Large / (L) Front Trim - Grime - Large / (L) Front Floor Mat - Missing - Yes / (R) Front Floor Mat - Missing - Yes / Mat Other - Missing - Yes</p> | <p><b>Remarks</b><br/>(L) Rear Fender - Repair Traces - Yes / Front Bumper, Grille, Lamps - Scratch &amp; Dent - Medium / (L) Front Door, Molding - Scratch - Small / (L) Front Fender, Molding - Scratch - Small / (L) Rear Door, Molding - Scratch - Small / (L) Step, In-panel, Side Spoiler - Scratch - Small / (L) Rear Fender, Molding - Repair mark - Yes / (L) Rear Fender, Molding - Scratch &amp; Dent - Medium / Rear Bumper, Lamps, Panels - Repair mark - Yes / Trunk Hood, Rear Gate - Crack, Gap - Medium / (R) Rear Fender, Molding - Scratch - Small / (R) Rear Door, Molding - Scratch - Large / (R) Rear Door, Molding - Repair mark - Yes / (R) Front Door, Molding - Scratch &amp; Dent - Large / (R) Step, In-panel, Side Spoiler - Scratch - Small / (L) Mirror - Scratch - Small</p> |
