## General Information

| Make | Toyota | Model | Vios |
| YOM | 2024 | Mileage | 3,463 |
| Registration No. | NFS3046 | Chassis No. | PA1B18F3R4242445 |

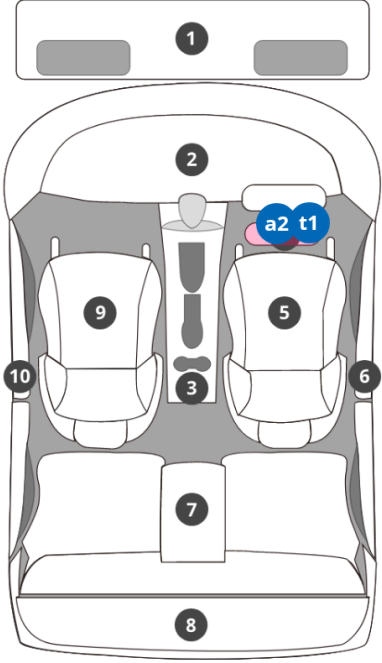
| Interior Evaluation : <b>A</b> | Exterior Evaluation : <b>B</b> |
|---|---|
| <p><b>Remarks</b><br/>(L) Front Floor Mat - Cut, Crack - Small / (R) Front Floor Mat - Cigarette Burns - Burnt Minimal</p> | <p><b>Remarks</b><br/>Front Bumper, Grille, Lamps - Scratch - Small / (L) Mirror - Scratch - Small / (L) Front Door, Molding - Scratch - Minimal / (L) Rear Door, Molding - Scratch - Small / Trunk Hood, Rear Gate - Scratch - Small / Rear Bumper, Lamps, Panels - Scratch - Small / Roof - Dent - Minimal / (R) Rear Fender, Molding - Scratch - Minimal / (R) Mirror - Scratch - Minimal / (R) Front Door, Molding - Scratch - Minimal / Bonnet, Headlight - Scratch - Medium</p> |

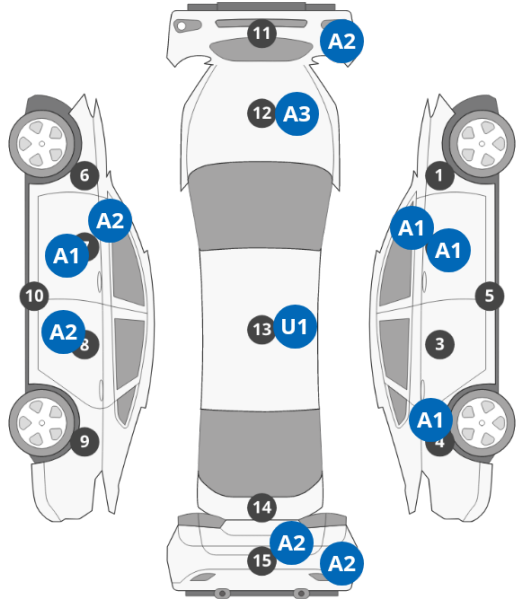
| Inspector Notes |
|---|
| swirlmarks and hairline scratches around the exterior. no tools. with user manual and without warranty booklet. |
