## General Information

| Make | Toyota | Model | Vios |
| YOM | 2021 | Odo Meter Reading | 51,398 |
| Registration No. | BAE9636 | Chassis No. | PA1B18F39M4148298 |

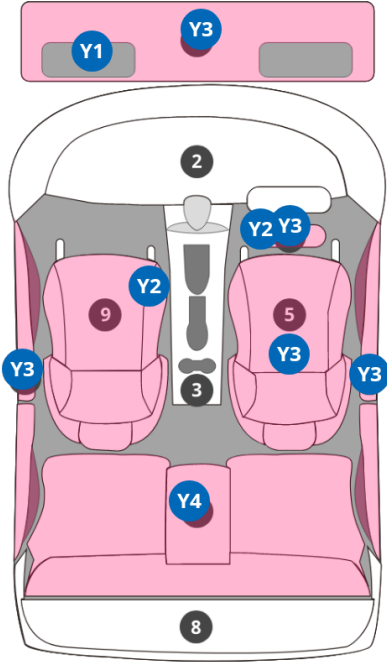
| Interior Evaluation : <b>D</b> | Exterior Evaluation : <b>E</b> |
| <p><b>Remarks</b></p> <p>Ceiling - Grime - Medium / (R) Front Trim - Grime - Medium / (R) Front Seat - Grime - Medium / Rear Seat - Grime - Large / Mat Other - Grime - Medium / (L) Front Trim - Grime - Medium / (L) Front Seat - Grime - Small / (L) Front Floor Mat - Grime - Small / Sunvisor, Sunglass Holder - Grime - Minimal</p> | <p><b>Remarks</b></p> <p>(L) Front Fender, Molding - Scratch - Medium / (L) Mirror - Scratch - Small / (L) Step, In-panel, Side Spoiler - Scratch &amp; Dent - Large / (L) Front Door, Molding - Scratch &amp; Dent - Large / (L) Rear Door, Molding - Scratch &amp; Dent - Medium / (L) Rear Fender, Molding - Scratch &amp; Dent - Small / Trunk Hood, Rear Gate - Scratch &amp; Dent - Small / Rear Bumper, Lamps, Panels - Scratch &amp; Dent - Large / (R) Rear Fender, Molding - Scratch - Medium / (R) Step, In-panel, Side Spoiler - Scratch &amp; Dent - Medium / (R) Front Door, Molding - Scratch - Small / (R) Rear Door, Molding - Scratch - Small / (R) Mirror - Scratch - Small / (R) Front Fender, Molding - Scratch - Small / Bonnet, Headlight - Dent - Medium / Front Bumper, Grille, Lamps - Scratch &amp; Dent - Large</p> |
