## General Information

| Make | Toyota | Model | Vios |
| Registration No. | NHD2580 | Chassis No. | PA1B18F32N4198915 |

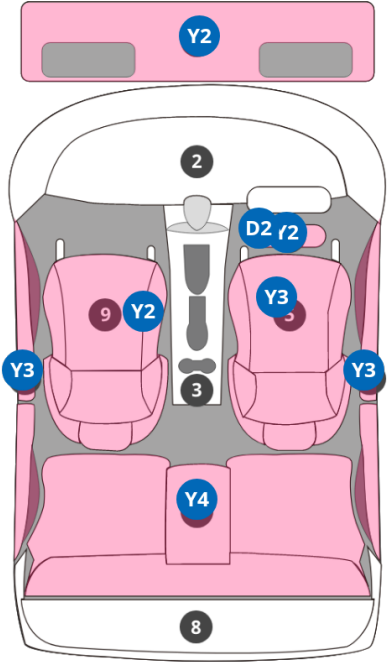
| Interior Evaluation : <b>C</b> | Exterior Evaluation : <b>C</b> |
|---|---|
| <p><b>Remarks</b></p> <p>Ceiling - Grime - Small / (R) Front Trim - Grime - Medium / (R) Front Seat - Grime - Medium / Rear Seat - Grime - Large / Mat Other - Grime - Small / (L) Front Trim - Grime - Medium / (L) Front Seat - Grime - Small / (L) Front Floor Mat - Worked - Small</p> | <p><b>Remarks</b></p> <p>(L) Step - Repair Traces - Yes / (L) Rear Fender - Repair Traces - Yes / Roof - Repair Traces - Yes / Roof - Repair mark - Difference in Color / (L) Rear Fender, Molding - Repair mark - Yes / (L) Mirror - Scratch - Small / (L) Front Door, Molding - Scratch - Small / Bonnet, Headlight - Scratch - Small / (R) Rear Fender, Molding - Scratch - Small / (R) Rear Door, Molding - Scratch - Minimal / Front Bumper, Grille, Lamps - Scratch &amp; Dent - Large / Rear Bumper, Lamps, Panels - Scratch - Small / (R) Mirror - Crack - Damaged</p> |

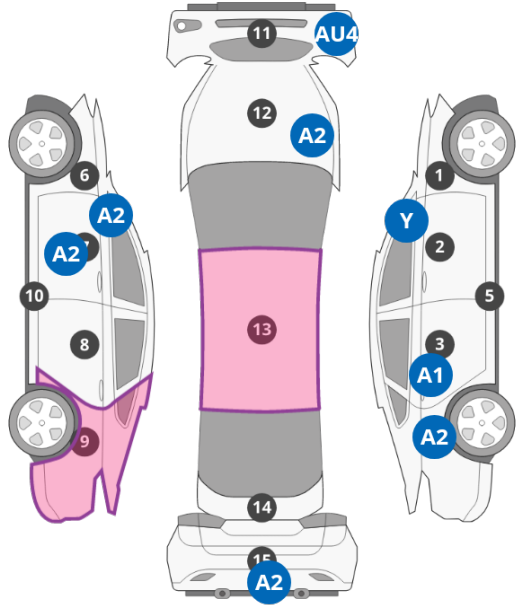
| Inspector Notes |
|---|
| <p>Roof and side mirrors wrapped in black. Right side mirror issue. Aftermarket rear view mirror loose. Without warranty booklet, tools and seat cover. with spare tire and jack. 1 key. With LTO plate.</p> |
