## General Information

| Make | Toyota | Model | Vios |
| YOM | 2022 | Odo Meter Reading | 27,212 |

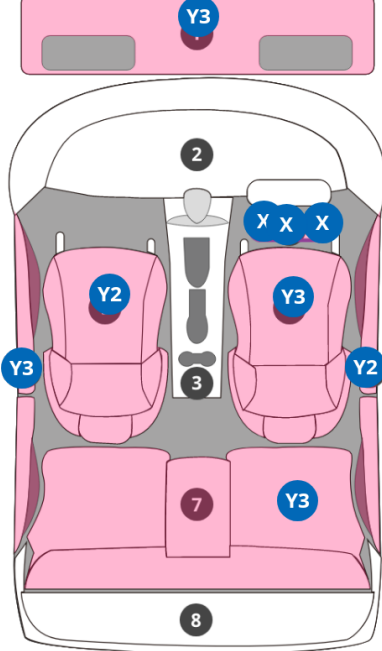
| Interior Evaluation : <span style="color: red;">C</span> | Exterior Evaluation : <span style="color: red;">C</span> |
|---|---|
| <p><b>Remarks</b></p> <p>Ceiling - Grime - Medium / (R) Front Trim - Grime - Small / (L) Front Floor Mat - Missing - Yes / (R) Front Floor Mat - Missing - Yes / Mat Other - Missing - Yes / (R) Front Seat - Grime - Medium / Rear Seat - Grime - Medium / (L) Front Trim - Grime - Medium / (L) Front Seat - Grime - Small</p> | <p><b>Remarks</b></p> <p>(R) Step - Repair Traces - Yes / (R) Front Fender - Repair Traces - Yes / Trunk Hood, Rear Gate - Repair Traces - Yes / (R) Rear Fender - Repair Traces - Yes / (R) Mirror - Scratch - Small / (R) Front Fender, Molding - Scratch - Small / (R) Rear Fender, Molding - Scratch &amp; Dent - Small / (R) Rear Door, Molding - Crack, Gap - Medium / (R) Rear Door, Molding - Repair mark - Yes / (L) Rear Fender, Molding - Scratch - Small / Rear Bumper, Lamps, Panels - Scratch &amp; Dent - Minimal / (L) Front Door, Molding - Scratch &amp; Dent - Small / (L) Rear Door, Molding - Scratch - Small / (L) Mirror - Scratch - Minimal / (L) Front Fender, Molding - Scratch - Small / Front Bumper, Grille, Lamps - Scratch &amp; Dent - Large</p> |

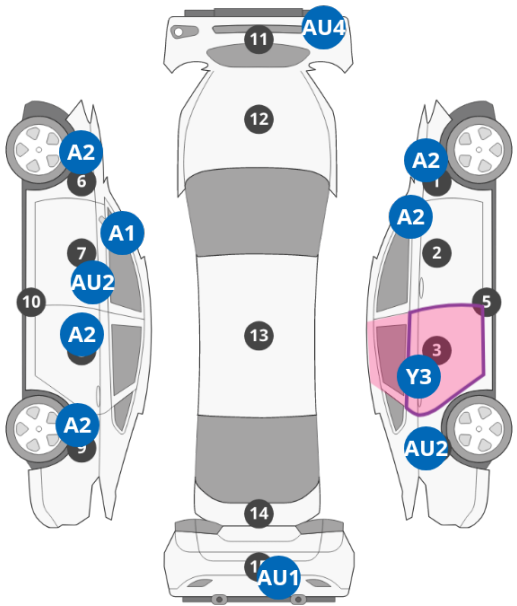
| Inspector Notes |
|---|
| <p>Crack and scratches on taillight. Headlight lowbeam missing. Hazard light issue. Glove box issue. With warranty booklet, spare tire and jack. Without tools. 1 key. With LTO plate.</p> |
