## General Information

| Make | Toyota | Model | Vios |
| YOM | 2021 | Odo Meter Reading | 73,657 |
| Registration No. | CBK3342 | Chassis No. | PA1B18F35M4142028 |

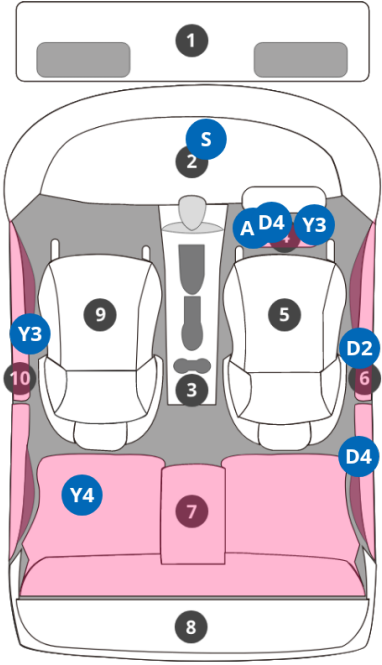
| Interior Evaluation : <span style="color: red;">D</span> | Exterior Evaluation : <span style="color: red;">E</span> |
| <b>Remarks</b><br>Mat Other - Grime - Medium / Rear Seat - Grime - Large / (L) Front Floor Mat - Cut, Crack - Large / (R) Front Floor Mat - Worked - Large / (R) Front Trim - Worked - Small / (R) Rear Trim - Worked - Large / (L) Front Trim - Grime - Medium / Overall Interior - Smell - Yes | <b>Remarks</b><br>(R) Front Door - Repair Traces - Yes / Bonnet, Headlight - Scratch & Dent - Large / Front Bumper, Grille, Lamps - Scratch & Dent - Large / Overall Exterior - Faded(Color, Gloss) - Yes / (L) Front Fender, Molding - Scratch & Dent - Medium / (L) Front Door, Molding - Scratch & Dent - Large / (L) Step, In-panel, Side Spoiler - Scratch & Dent - Medium / (L) Rear Fender, Molding - Scratch - Large / Rear Bumper, Lamps, Panels - Scratch - Large / Trunk Hood, Rear Gate - Scratch & Dent - Medium / (R) Rear Fender, Molding - Repair mark - Yes / (R) Front Door, Molding - Repair mark - Yes / (R) Rear Door, Molding - Repair mark - Yes / (R) Rear Fender, Molding - Scratch - Large / (R) Rear Door, Molding - Scratch & Dent - Large / (R) Front Door, Molding - Scratch & Dent - Large / (R) Step, In-panel, Side Spoiler - Scratch & Dent - Large / (R) Front Fender, Molding - Scratch & Dent - Medium / Member (Bolted) - Dent - Yes / Roof - Dent - Small / (L) Rear Door, Molding - Scratch & Dent - Large |
