## General Information

| Make | Toyota | Model | Vios |

## Body / Panel Condition

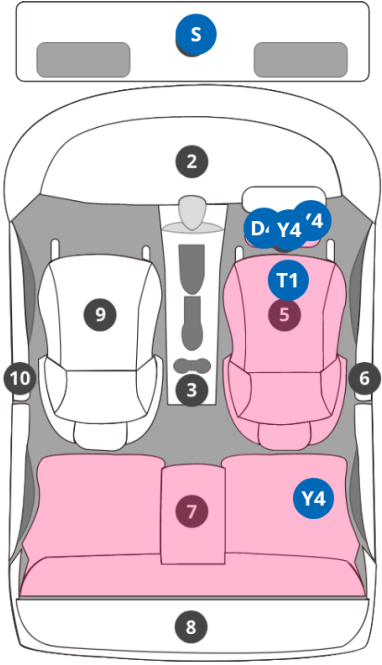
| Interior Evaluation : <span>C</span> | Exterior Evaluation : <span>C</span> |
| <b>Remarks</b><br>(L) Front Floor Mat - Worked - Large / Rear Seat - Grime - Large / Mat Other - Grime - Large / (R) Front Floor Mat - Grime - Large / Overall Interior - Smell - Yes / (R) Front Seat - Cigarette Burns - Burnt Minimal | <b>Remarks</b><br>(L) Front Door, Molding - Scratch & Dent - Small / (L) Rear Door, Molding - Scratch & Dent - Medium / (L) Step, In-panel, Side Spoiler - Scratch - Small / (L) Rear Fender, Molding - Scratch - Small / Rear Bumper, Lamps, Panels - Scratch & Dent - Medium / Trunk Hood, Rear Gate - Scratch & Dent - Small / (R) Rear Fender, Molding - Dent - Small / (R) Rear Door, Molding - Scratch & Dent - Small / (R) Step, In-panel, Side Spoiler - Scratch - Small / (R) Front Door, Molding - Scratch - Small / (R) Front Fender, Molding - Scratch & Dent - Small / Front Bumper, Grille, Lamps - Crack, Gap - Small |
