## General Information

| Make | Toyota | Model | Vios |

## Body / Panel Condition

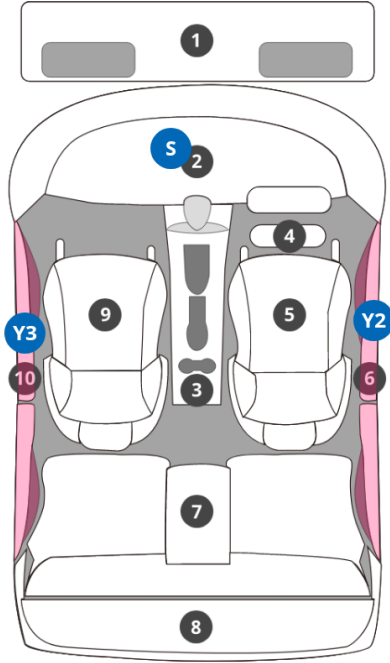
| Interior Evaluation : <b>B</b> | Exterior Evaluation : <b>E</b> |
| <b>Remarks</b><br>(L) Front Trim - Grime - Medium / (R) Front Trim - Grime - Small / Overall Interior - Smell - Yes | <b>Remarks</b><br>(R) Front Door - Repair Traces - Yes / (R) Front Fender - Repair Traces - Yes / Trunk Hood, Rear Gate - Repair Traces - Yes / Rear Bumper, Lamps, Panels - Modified - Large / Trunk Hood, Rear Gate - Crack, Gap - Large / (R) Front Fender, Molding - Repair mark - Yes / (R) Front Fender, Molding - Dent - Medium / Front Bumper, Grille, Lamps - Scratch & Dent - Large / (L) Front Door, Molding - Scratch - Small / (L) Rear Door, Molding - Scratch - Small / (R) Front Door, Molding - Scratch - Small / (R) Rear Door, Molding - Scratch - Small / (R) Step, In-panel, Side Spoiler - Scratch - Small / (L) Step, In-panel, Side Spoiler - Crack, Gap - Small / (L) Rear Fender, Molding - Scratch & Dent - Small / Roof - Dent - Small |
