## General Information

| Make | Toyota | Model | Vios |
| Registration No. | NKM2892 | Chassis No. | PA1B18F39R4276967 |

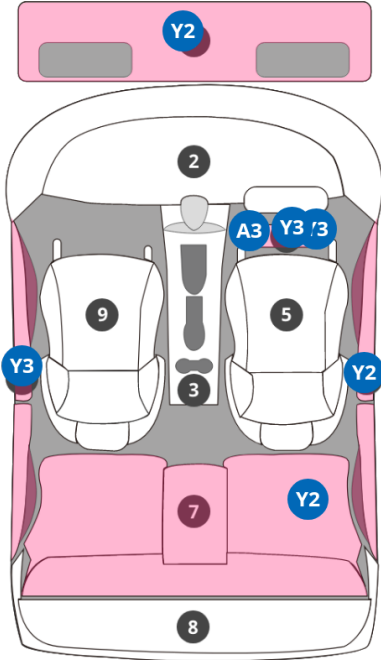
| Interior Evaluation : C | | Exterior Evaluation : C | |
| <b>Remarks</b><br>Ceiling - Grime - Small / (R) Front Trim - Grime - Small / (R) Front Floor Mat - Grime - Medium / Mat Other - Grime - Medium / Rear Seat - Grime - Small / (L) Front Trim - Grime - Medium / (L) Front Floor Mat - Cut, Crack - Medium | | <b>Remarks</b><br>Rear Bumper, Lamps, Panels - Scratch & Dent - Large / (L) Rear Fender, Molding - Scratch & Dent - Large / Trunk Hood, Rear Gate - Scratch & Dent - Small / (R) Rear Door, Molding - Scratch - Minimal / (R) Front Door, Molding - Scratch - Small / (R) Front Fender, Molding - Scratch - Small / Front Bumper, Grille, Lamps - Scratch & Dent - Large / (L) Mirror - Scratch - Small / (L) Front Door, Molding - Scratch - Small | |
