## General Information

| Make | Toyota | Model | Vios |
| YOM | 2024 | Mileage | 12,102 |
| Registration No. | EAG6754 | Chassis No. | PA1B18F37P4232902 |

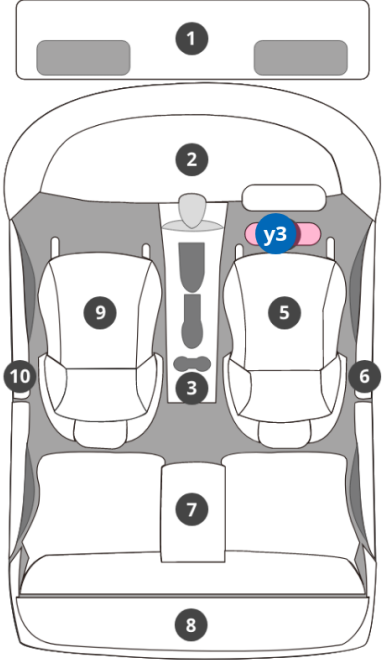
| Interior Evaluation : <b>B</b> | Exterior Evaluation : <b>B</b> |
|---|---|
| <b>Remarks</b><br>(L) Front Floor Mat - Grime - Medium | <b>Remarks</b><br>(L) Front Door - Repair Traces - Yes / (L) Step - Repair Traces - Yes / (L) Rear Door - Repair Traces - Yes / (L) Rear Fender - Repair Traces - Yes / Front Bumper, Grille, Lamps - Scratch - Small / (L) Mirror - Scratch - Minimal / (L) Front Door, Molding - Scratch - Medium / (L) Rear Fender, Molding - Scratch - Small / Rear Bumper, Lamps, Panels - Scratch - Small / (R) Mirror - Scratch - Minimal |

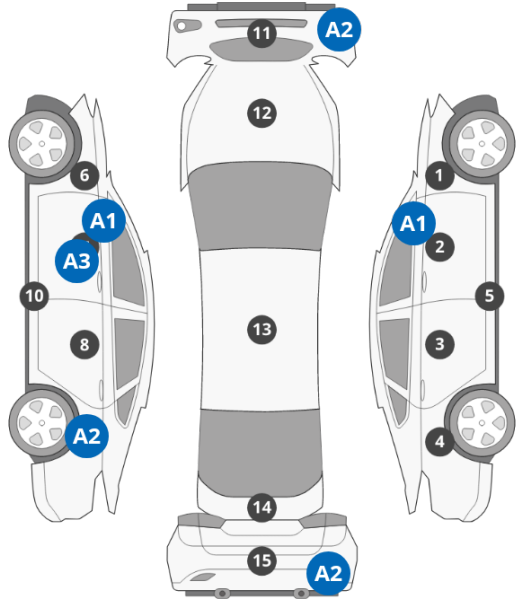
swirlmarks and hairline scratches around the exterior. without user manual. with warranty booklet.
