## General Information

| Make | Toyota | Model | Vios |
| Registration No. | CCE8120 | Chassis No. | PA1B18F3XR465203 |

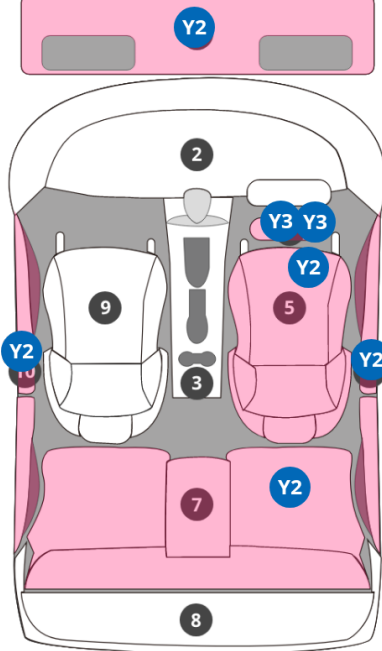
| Interior Evaluation : <b>B</b> | Exterior Evaluation : <b>C</b> |
|---|---|
| <p><b>Remarks</b><br/>Ceiling - Grime - Small / (R) Front Trim - Grime - Small / (R) Front Floor Mat - Grime - Medium / (R) Front Seat - Grime - Small / Mat Other - Grime - Medium / Rear Seat - Grime - Small / (L) Front Trim - Grime - Small</p> | <p><b>Remarks</b><br/>Front Bumper, Grille, Lamps - Crack, Gap - Medium / (L) Front Fender, Molding - Scratch - Minimal / (L) Front Door, Molding - Scratch - Minimal / (L) Rear Door, Molding - Scratch - Minimal / (L) Rear Fender, Molding - Scratch - Minimal / Rear Bumper, Lamps, Panels - Scratch &amp; Dent - Large / (R) Rear Fender, Molding - Scratch &amp; Dent - Minimal / (R) Rear Door, Molding - Scratch - Small / (R) Side Window - Scratch, Stone chip - Medium</p> |

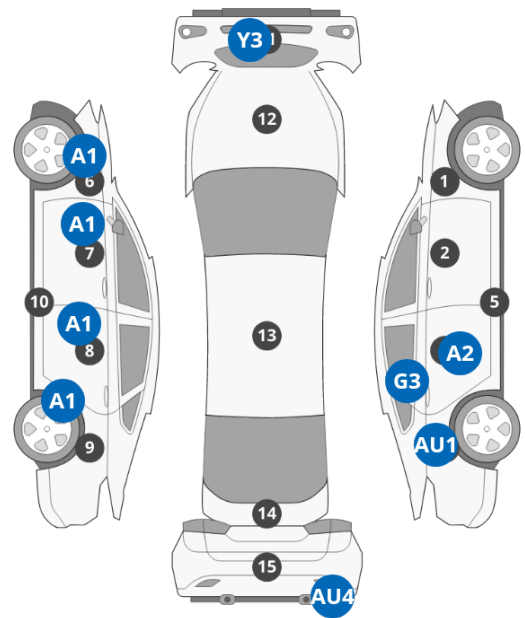
| Inspector Notes |
|---|
| Damaged grille. Toe hook cover missing. With warranty booklet and spare tire. Without jack, tools and seat cover. 1 key. With LTO plate. |
