## General Information

| Make | Toyota | Model | Vios |
| Registration No. | CCF2184 | Chassis No. | PA1B18F30R4260091 |

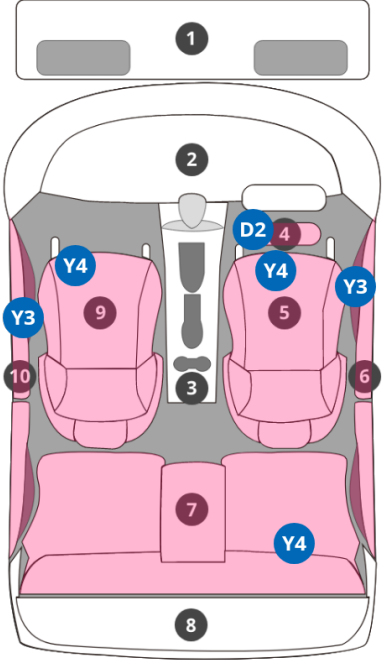
| Interior Evaluation : <span style="color: red;">C</span> | Exterior Evaluation : <span style="color: red;">E</span> |
| <b>Remarks</b><br>Rear Seat - Grime - Large / (L) Front Seat - Grime - Large / (L) Front Floor Mat - Worked - Small / (R) Front Seat - Grime - Large / (L) Front Trim - Grime - Medium / (R) Front Trim - Grime - Medium | <b>Remarks</b><br>(L) Rear Door - Repair Traces - Yes / (L) Rear Fender - Repair Traces - Yes / Trunk Hood, Rear Gate - Repair Traces - Yes / Rear End Panel - Repair Traces - Yes / (R) Rear Fender - Repair Traces - Yes / (R) Rear Fender - Replaced - Yes / (L) Rear Fender, Molding - Repair mark - Yes / Rear Bumper, Lamps, Panels - Repair mark - Yes / Trunk Hood, Rear Gate - Repair mark - Yes / Rear Bumper, Lamps, Panels - Scratch & Dent - Medium / (R) Rear Fender, Molding - Scratch - Small / (R) Rear Door, Molding - Crack, Gap - Large / Front Bumper, Grille, Lamps - Scratch - Medium / Bonnet, Headlight - Scratch - Small / (L) Step, In-panel, Side Spoiler - Scratch & Dent - Small / (L) Front Door, Molding - Scratch - Small / (L) Rear Door, Molding - Scratch - Small / (L) Front Fender, Molding - Scratch - Small / (R) Front Door, Molding - Scratch - Small / (R) Front Fender, Molding - Scratch - Small / Roof - Scratch - Small |
