## General Information

| Make | Toyota | Model | Vios |

## Body / Panel Condition

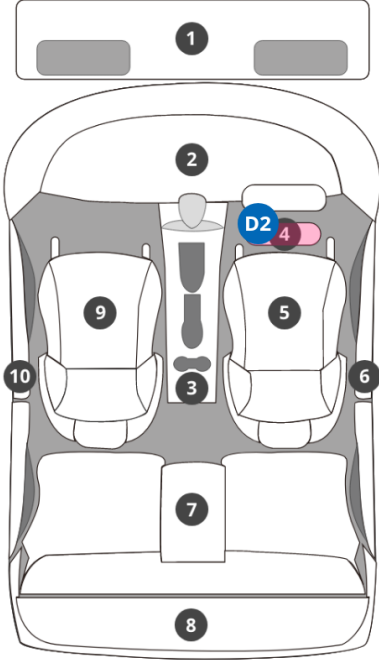
| Interior Evaluation : <span style="color: red; font-weight: bold;">A</span> | Exterior Evaluation : <span style="color: red; font-weight: bold;">B</span> |
| <b>Remarks</b><br>(L) Front Floor Mat - Worked - Small | <b>Remarks</b><br>(L) Front Door, Molding - Dent - Small / (L) Rear Door, Molding - Scratch - Small / Rear Bumper, Lamps, Panels - Scratch - Small / Trunk Hood, Rear Gate - Scratch - Small / (L) Front Fender, Molding - Scratch - Small / (L) Step, In-panel, Side Spoiler - Scratch - Minimal / (R) Step, In-panel, Side Spoiler - Scratch - Minimal / Front Bumper, Grille, Lamps - Scratch - Small / (R) Front Fender, Molding - Dent - Small / (R) Front Door, Molding - Dent - Small |
