## General Information

| Make | Toyota | Model | Wigo |

## Body / Panel Condition

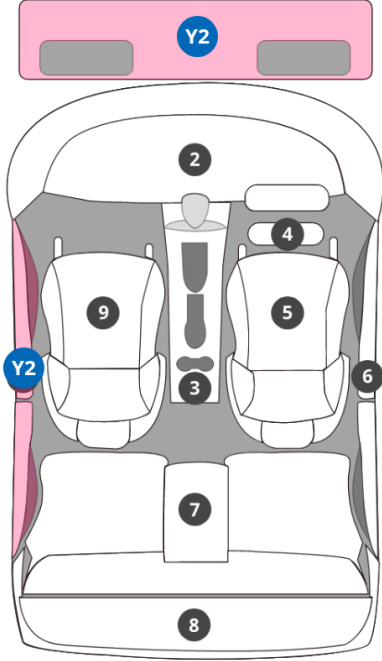
| Interior Evaluation : <b>A</b> | Exterior Evaluation : <b>C</b> |
|---|---|
| <b>Remarks</b><br>Ceiling - Grime - Small / (L) Front Trim - Grime - Small | <b>Remarks</b><br>Front Bumper, Grille, Lamps - Scratch & Dent - Medium / (R) Front Door, Molding - Scratch & Dent - Medium / (R) Front Fender, Molding - Scratch & Dent - Small / Rear Bumper, Lamps, Panels - Scratch & Dent - Medium / (L) Rear Door, Molding - Scratch - Medium / (L) Mirror - Scratch - Small / (L) Front Door, Molding - Scratch - Medium / (L) Front Fender, Molding - Scratch - Medium / (R) Rear Fender, Molding - Scratch & Dent - Small |
