## General Information

| Make | Toyota | Model | Vios |

## Body / Panel Condition

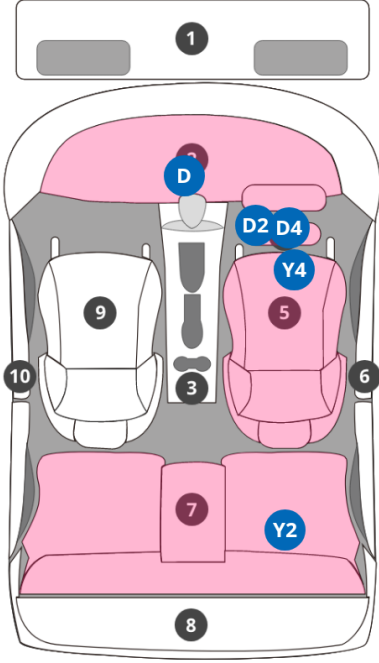
| Interior Evaluation : <b>C</b> | Exterior Evaluation : <b>C</b> |
|---|---|
| <p><b>Remarks</b><br/>Rear Seat - Grime - Small / (L) Front Floor Mat - Worked - Small / (R) Front Floor Mat - Worked - Large / Dashboard - Traces of Adhesive Tape - Yes / (R) Front Seat - Grime - Large</p> | <p><b>Remarks</b><br/>Bonnet - Repair Traces - Yes / (L) Rear Door - Repair Traces - Yes / (L) Rear Fender - Repair Traces - Yes / (R) Front Door, Molding - Scratch &amp; Dent - Large / Front Bumper, Grille, Lamps - Scratch - Medium / (L) Front Fender, Molding - Scratch &amp; Dent - Small / (L) Rear Fender, Molding - Dent - Small / (R) Rear Door, Molding - Scratch - Small / (R) Step, In-panel, Side Spoiler - Scratch - Small / Bonnet, Headlight - Scratch - Small / (R) Mirror - Scratch - Minimal / Roof - Scratch - Medium / Rear Bumper, Lamps, Panels - Scratch - Small / Trunk Hood, Rear Gate - Scratch - Small</p> |
