## General Information

| Make | Toyota | Model | Vios |
| Registration No. | NIN4880 | Chassis No. | PA1B18F35P4209487 |

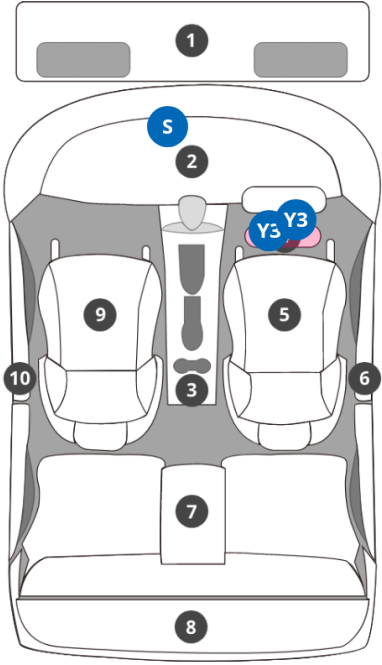
| Interior Evaluation : <b>B</b> | Exterior Evaluation : <b>E</b> |
|---|---|
| <p><b>Remarks</b><br/>(L) Front Floor Mat - Grime - Medium / Mat Other - Grime - Medium / Overall Interior - Smell - Yes</p> | <p><b>Remarks</b><br/>(R) Rear Door, Molding - Scratch &amp; Dent - Medium / (R) Rear Fender, Molding - Scratch &amp; Dent - Medium / (R) Front Door, Molding - Scratch - Large / (R) Step, In-panel, Side Spoiler - Scratch &amp; Dent - Large / (R) Front Fender, Molding - Scratch - Small / Front Bumper, Grille, Lamps - Scratch &amp; Dent - Large / (L) Front Door, Molding - Scratch - Medium / (L) Step, In-panel, Side Spoiler - Scratch &amp; Dent - Large / (L) Rear Door, Molding - Scratch - Medium / (L) Rear Fender, Molding - Scratch - Medium</p> |
