## General Information

| Make | Toyota | Model | Vios |
| Registration No. | BAG7575 | Chassis No. | PA1B18F37R4271105 |

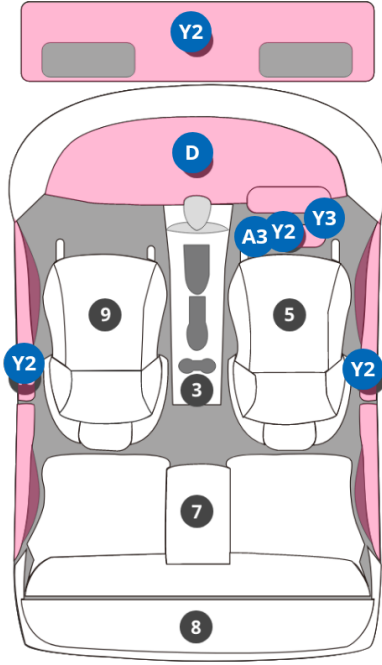
| Interior Evaluation : <b>B</b> | Exterior Evaluation : <b>C</b> |
|---|---|
| <p><b>a</b> : Cut, Fray <b>d</b> : Loose, Deformed <b>k</b> : Animal Hair <b>s</b> : Smell <b>t</b> : Cigarette Burns <b>x</b> : Defective <b>y</b> : Stain</p> | <p><b>A</b> : Scratch <b>AU</b> : Scratch &amp; Dent <b>B</b> : Modified <b>C</b> : Corrosion <b>G</b> : Stone chip <b>P</b> : Faded <b>S</b> : Rust <b>SC</b> : Rust &amp; Corrosion <b>U</b> : Dent <b>X</b> : Defective <b>Y</b> : Crack, Gap</p> |
| <p><b>Remarks</b><br/>Ceiling - Grime - Small / (R) Front Trim - Grime - Small / (R) Front Floor Mat - Grime - Medium / Mat Other - Grime - Small / (L) Front Trim - Grime - Small / (L) Front Floor Mat - Cut, Crack - Medium / Dashboard - Traces of Adhesive Tape - Yes</p> | <p><b>Remarks</b><br/>Rear Windshield - Damaged - Large / Rear Bumper, Lamps, Panels - Scratch &amp; Dent - Small / (L) Rear Fender, Molding - Scratch - Small / (L) Rear Door, Molding - Scratch - Small / (L) Mirror - Scratch - Minimal / (L) Front Door, Molding - Scratch - Small / Front Bumper, Grille, Lamps - Scratch &amp; Dent - Large / (R) Mirror - Scratch - Small / (R) Rear Door, Molding - Scratch - Small / (R) Rear Fender, Molding - Scratch - Small</p> |

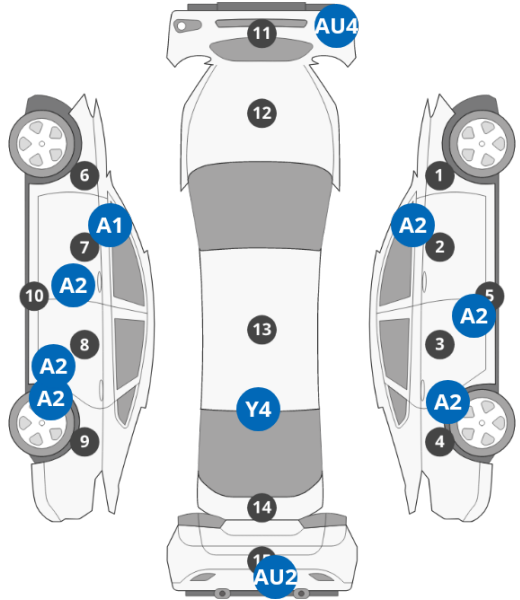
| Inspector Notes |
|---|
| Damaged Rear Windshield. Grime at dashboard. With warranty booklet, spare tire, jack, tools and seat cover. 3 keys. With LTO plate. |
