## General Information

| Make | Toyota | Model | Innova |
| YOM | 2025 | Odo Meter Reading | 4,497 |
| Registration No. | NJE1950 | Chassis No. | PA2JABEMXR01469650 |

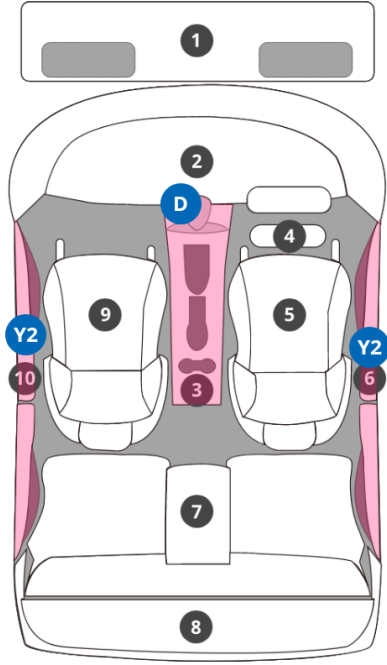
| Interior Evaluation : <span style="color: red;">A</span> | Exterior Evaluation : <span style="color: red;">C</span> |
| <p><b>Remarks</b><br/>Console, Switches, Vents - Traces of Adhesive Tape - Yes / (R) Front Trim - Grime - Small / (L) Front Trim - Grime - Small</p> | <p><b>Remarks</b><br/>(R) Front Fender, Molding - Scratch - Minimal / (R) Mirror - Scratch - Minimal / (R) Front Door, Molding - Scratch - Large / (R) Rear Door, Molding - Scratch - Medium / (R) Rear Fender, Molding - Scratch &amp; Dent - Small / Rear Bumper, Lamps, Panels - Scratch - Small / Trunk Hood, Rear Gate - Scratch &amp; Dent - Minimal / (L) Rear Fender, Molding - Scratch - Minimal / (L) Rear Door, Molding - Scratch - Small / (L) Front Door, Molding - Scratch - Medium / (L) Front Fender, Molding - Scratch - Minimal / (L) Mirror - Scratch - Minimal / Bonnet, Headlight - Scratch &amp; Dent - Small / Front Bumper, Grille, Lamps - Scratch - Small / Roof - Scratch &amp; Dent - Minimal</p> |
