## General Information

| Make | Chevrolet | Model | Trax |
| YOM | 2017 | Odo Meter Reading | 55,382 |

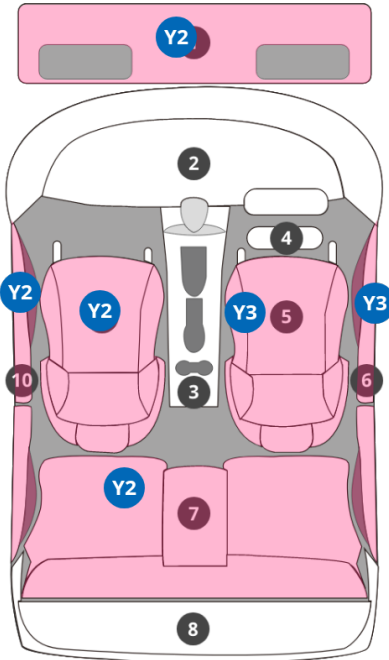
| Interior Evaluation : <span style="color: red; font-weight: bold;">B</span> | | Exterior Evaluation : <span style="color: red; font-weight: bold;">B</span> | |
| <p><b>Remarks</b></p> <p>(R) Front Trim - Grime - Medium / Rear Seat - Grime - Small / (L) Front Trim - Grime - Small / (L) Front Seat - Grime - Small / (R) Front Seat - Grime - Medium / Ceiling - Grime - Small</p> | | <p><b>Remarks</b></p> <p>(R) Front Fender - Repair Traces - Yes / Bonnet - Repair Traces - Yes / Bonnet, Headlight - Repair mark - Yes / (R) Front Fender, Molding - Repair mark - Yes / (R) Rear Door, Molding - Scratch &amp; Dent - Small / (R) Mirror - Scratch - Minimal / (L) Rear Door, Molding - Scratch &amp; Dent - Small / (L) Rear Fender, Molding - Dent - Minimal / Trunk Hood, Rear Gate - Scratch - Minimal / (R) Rear Fender, Molding - Dent - Minimal / (R) Front Fender, Molding - Scratch - Minimal / (L) Front Fender, Molding - Scratch - Minimal / Rear Bumper, Lamps, Panels - Scratch - Minimal</p> | |
