## General Information

| Make | Toyota | Model | Wigo |

## Body / Panel Condition

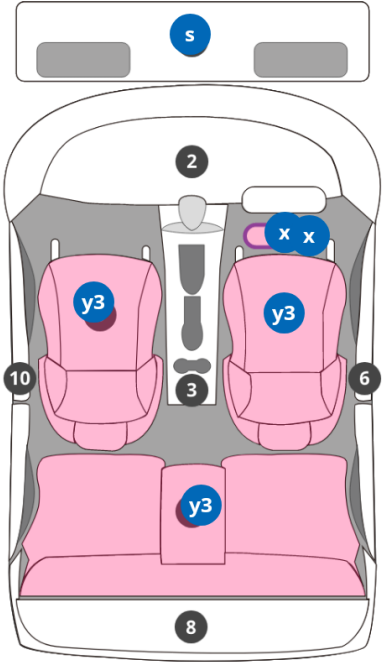
| Interior Evaluation : <b>B</b> | Exterior Evaluation : <b>E</b> |
| <p><b>Remarks</b><br/> (R) Front Floor Mat - Missing - Yes / (L) Front Floor Mat - Missing - Yes / (L) Front Seat - Grime - Medium / Rear Seat - Grime - Medium / (R) Front Seat - Grime - Medium / Overall Interior - Smell - Yes</p> | <p><b>Remarks</b><br/> Front Bumper, Grille, Lamps - Scratch - Small / (L) Front Door, Molding - Scratch - Medium / (L) Rear Door, Molding - Scratch - Small / Rear Bumper, Lamps, Panels - Scratch - Small / (R) Step, In-panel, Side Spoiler - Scratch &amp; Dent - Small / (R) Rear Fender, Molding - Scratch - Minimal / (R) Rear Door, Molding - Scratch &amp; Dent - Medium / (R) Front Door, Molding - Scratch &amp; Dent - Large / (R) Mirror - Scratch - Small / Bonnet, Headlight - Scratch - Small / Roof - Scratch - Small / (L) Side Window - Scratch, Stone chip - Large / (L) Center Panel - Scratch - Small / (L) Mirror - Crack - Damaged</p> |

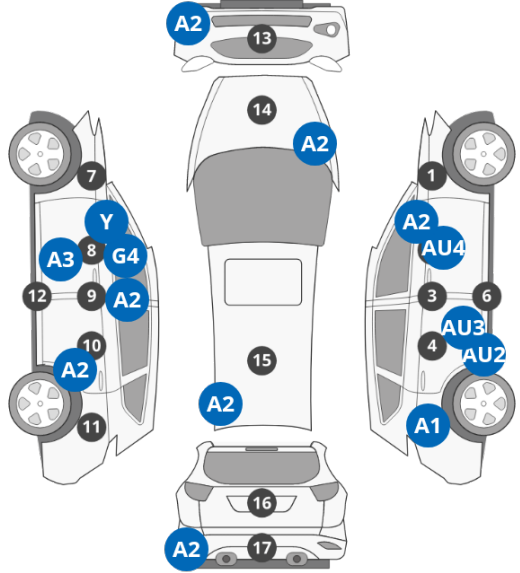
hairline scratches around the exterior. with user manual and warranty booklet. without tools and spare tire.
