## General Information

| Make | Toyota | Model | Vios |
| YOM | 2024 | Odo Meter Reading | 36,029 |
| Registration No. | NIU8991 | Chassis No. | PA1B18F31R4243476 |

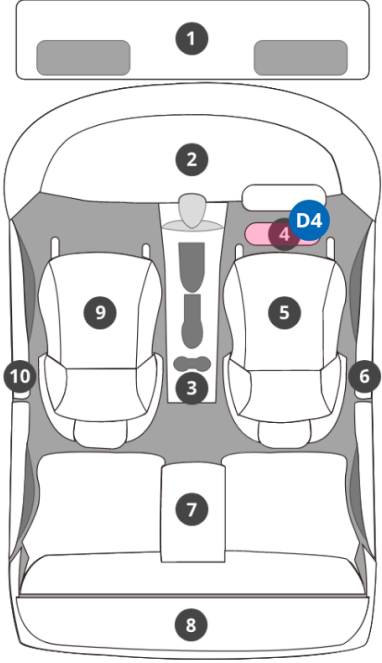
| Interior Evaluation : <b>C</b> | Exterior Evaluation : <b>E</b> |
|---|---|
| <b>Remarks</b><br>Mat Other - Worked - Large | <b>Remarks</b><br>Rear Bumper, Lamps, Panels - Repair mark - Difference in Color / Rear Bumper, Lamps, Panels - Scratch - Large / (L) Rear Fender, Molding - Scratch - Large / Trunk Hood, Rear Gate - Scratch - Medium / (R) Rear Fender, Molding - Scratch - Large / (L) Rear Door, Molding - Scratch - Large / (L) Front Door, Molding - Scratch - Medium / (L) Front Fender, Molding - Scratch - Large / Front Bumper, Grille, Lamps - Scratch & Dent - Medium / (R) Front Fender, Molding - Scratch & Dent - Large / (R) Front Door, Molding - Scratch - Large / (R) Step, In-panel, Side Spoiler - Scratch & Dent - Medium / (R) Rear Door, Molding - Scratch & Dent - Minimal / Bonnet, Headlight - Scratch - Large |
