## General Information

<b>Make</b>	Toyota	<b>Model</b>	Vios
<b>YOM</b>	2024	<b>Odo Meter Reading</b>	40,229
<b>Registration No.</b>	CAZ9852	<b>Chassis No.</b>	PA1B18F31R4239749
<b>CC</b>	1.3	<b>Transmission</b>	CVT
<b>Fuel Type</b>	Gas	<b>Type of Body</b>	Sedan
<b>Colour</b>	Silver

## Body / Panel Condition

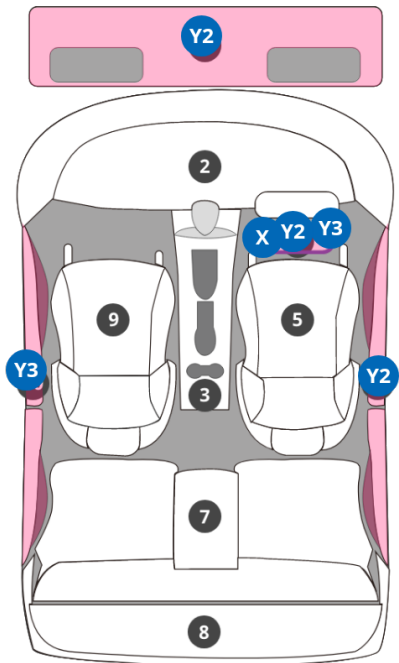
<b>Interior Evaluation :</b> <span style="float: right; color: red; font-weight: bold;">B</span>	<b>Exterior Evaluation :</b> <span style="float: right; color: red; font-weight: bold;">C</span>

<p><b>A</b> : Scratch <b>AU</b> : Scratch &amp; Dent <b>B</b> : Modified <b>C</b> : Corrosion <b>G</b> : Stone chip <b>P</b> : Faded <b>S</b> : Rust <b>SC</b> : Rust &amp; Corrosion <b>U</b> : Dent <b>X</b> : Defective <b>Y</b> : Crack, Gap</p>
<p><b>Remarks</b> Ceiling - Grime - Small / (R) Front Trim - Grime - Small / (R) Front Floor Mat - Grime - Medium / Mat Other - Grime - Small / (L) Front Trim - Grime - Medium / (L) Front Floor Mat - Missing - Yes</p>	<p><b>Remarks</b> Rear Bumper, Lamps, Panels - Scratch &amp; Dent - Large / Rear Bumper, Lamps, Panels - Repair mark - Yes / (L) Rear Fender, Molding - Scratch - Minimal / (L) Front Door, Molding - Scratch &amp; Dent - Minimal / (L) Rear Door, Molding - Scratch - Minimal / Front Bumper, Grille, Lamps - Repair mark - Yes / Front Bumper, Grille, Lamps - Scratch &amp; Dent - Large / Bonnet, Headlight - Scratch - Medium / (R) Front Fender, Molding - Scratch - Minimal / (R) Front Door, Molding - Scratch - Minimal / (R) Rear Fender, Molding - Dent - Minimal / (R) Rear Door, Molding - Scratch - Minimal</p>

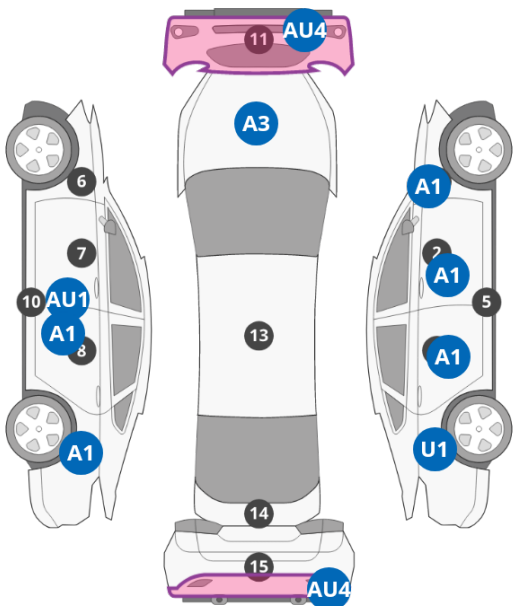
<p><b>Inspector Notes</b></p>
<p>Scratches and Crack on taillight. Gap at rear bumper. Without warranty booklet. With Spare tire,jack,tools and seat cover. 1 key. With LTO plate.</p>
